REPORT
OF THE
TECHNICAL ASSESSMENT PANEL

COLLAPSE OF THE 300 foot RADIO TELESCOPE

**REPORT of the TECHNICAL ASSESSMENT PANEL
for the
300 foot RADIO TELESCOPE at GREEN BANK, WV**

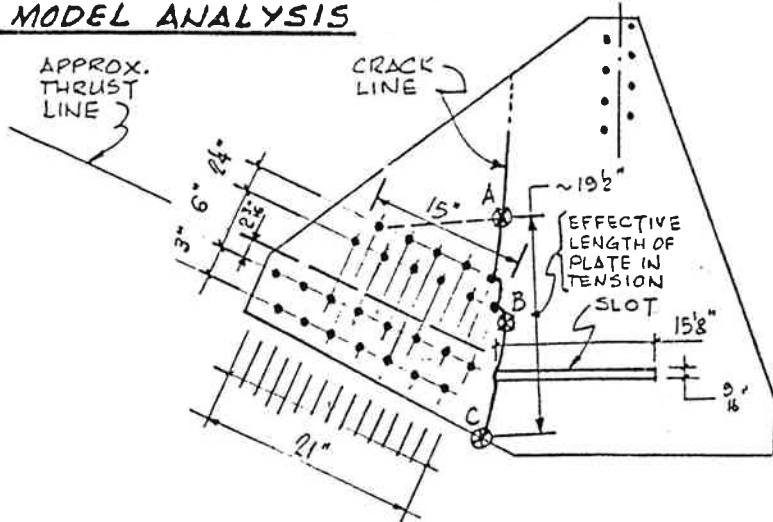
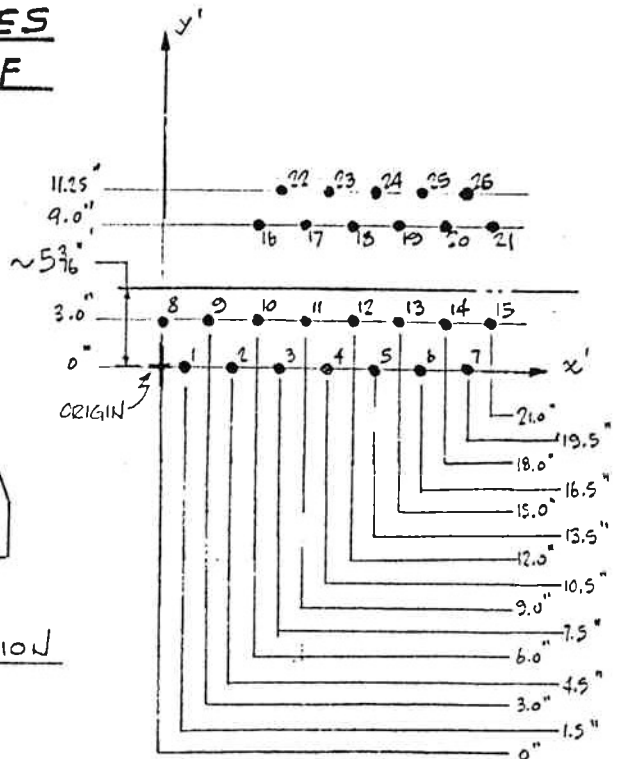
RUPTURED GUSSET PLATE ELEVATION

2) Visual inspection and laboratory tests of the ruptured gusset removed from the telescope wreckage indicated progressive cracking and eventual rupturing of this plate. The analysis showed that the plate stresses were high enough to cause cracking and crack growth under the cyclic loads from the antenna movements. Rupture of the plate would have resulted in the collapse of the telescope. It should be noted that the telescope had a history of several gusset plate replacements throughout its operational life.

RUPTURED GUSSET PLATE STRESSES DUE TO FORCES DETERMINED WITH HALF MODEL ANALYSIS

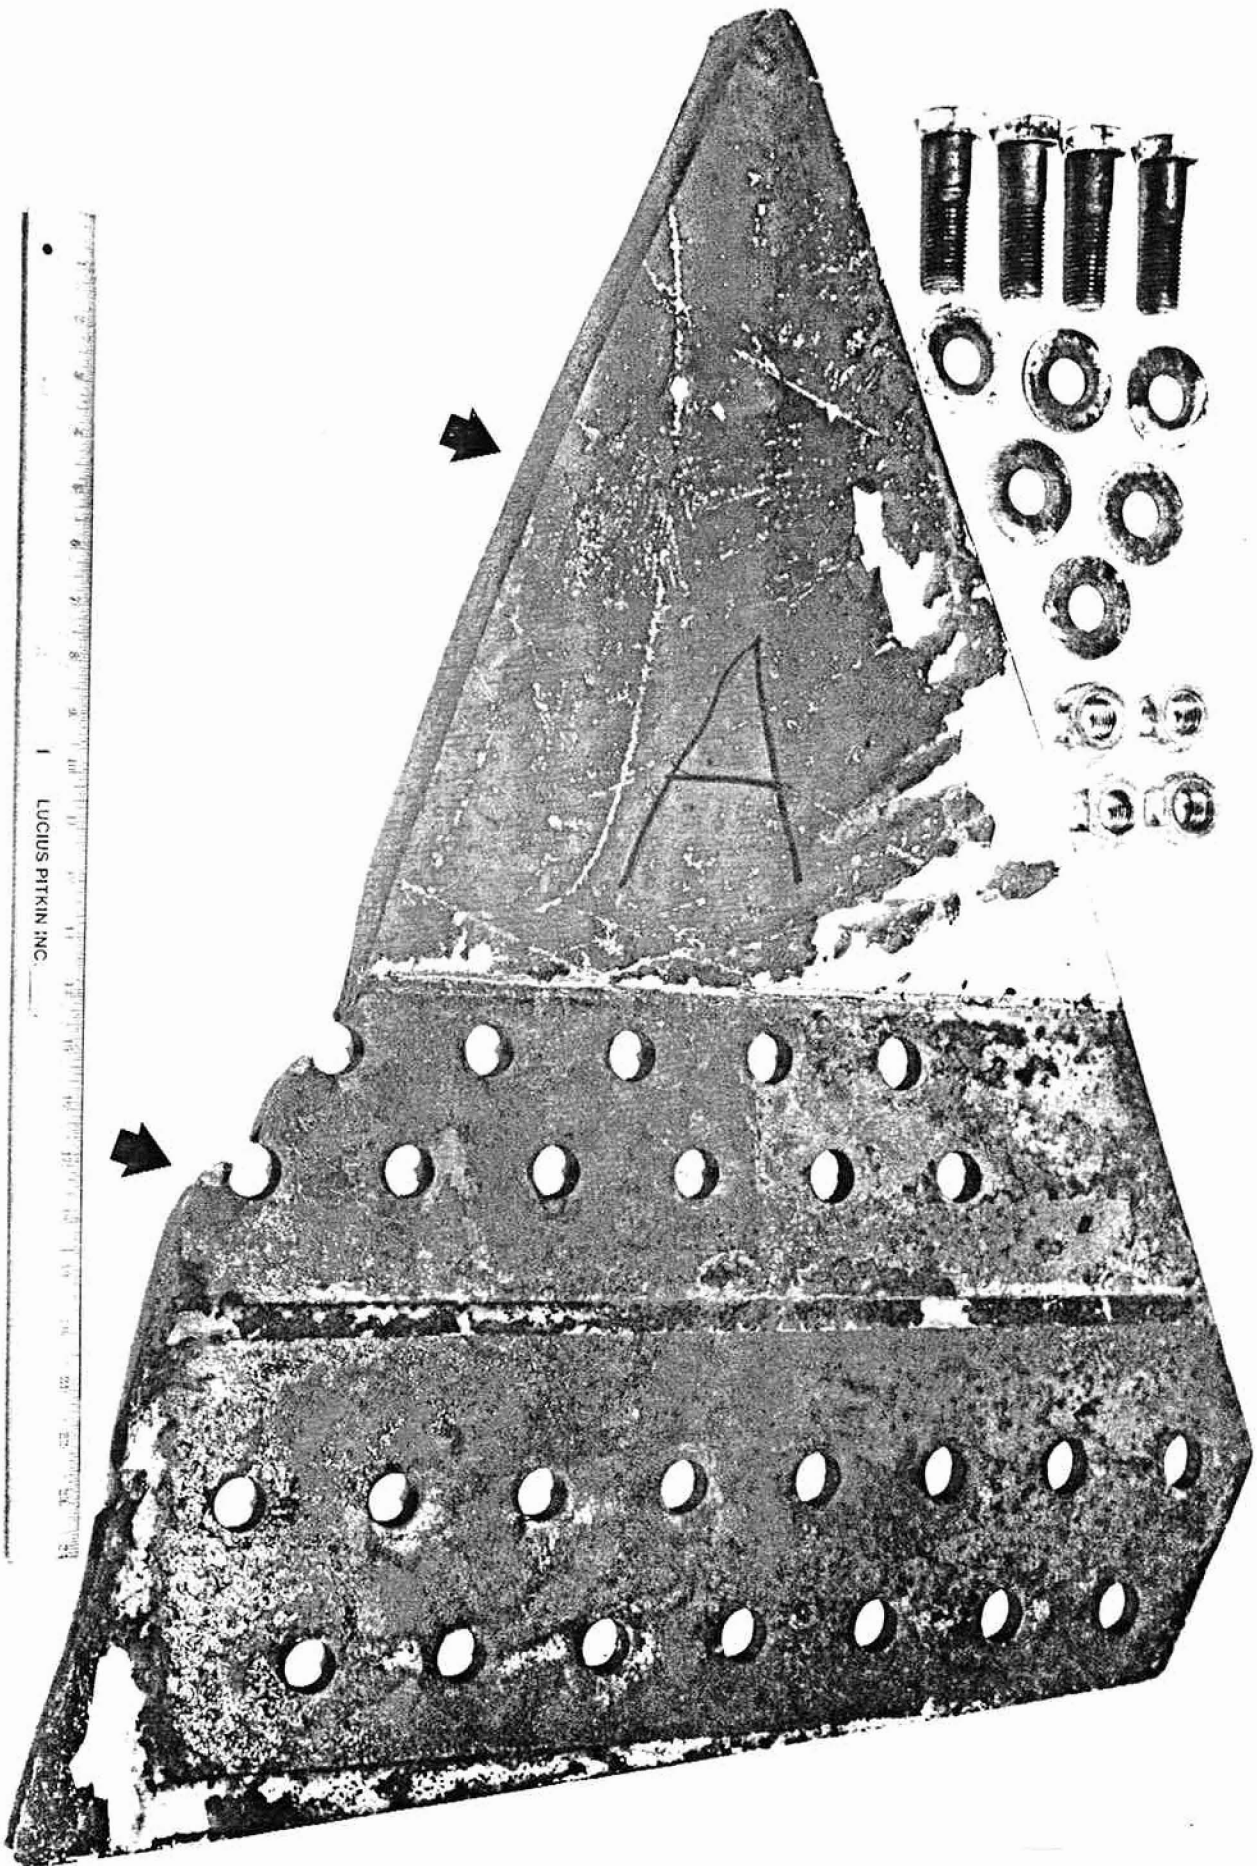
Photograph showing the submitted 1/2-in. thick main box girder plate from the 300 ft. radio telescope at Greenbank, West Virginia, in the as-received condition. The plate fracture was approximately 37 in. long (arrows) and intersected two bolt holes.

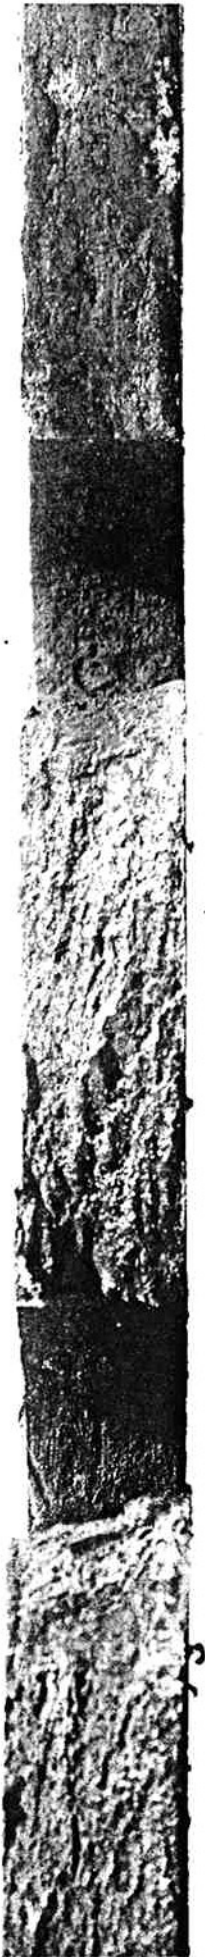
Photograph showing the flat and heavily oxidized appearance of the plate fracture surfaces adjacent to the bolt holes. This flat and heavily oxidized fracture appearance is characteristic of long-term progressive or fatigue cracking. The convergence of chevron-like marks indicates the bolt holes to be the fracture origins.

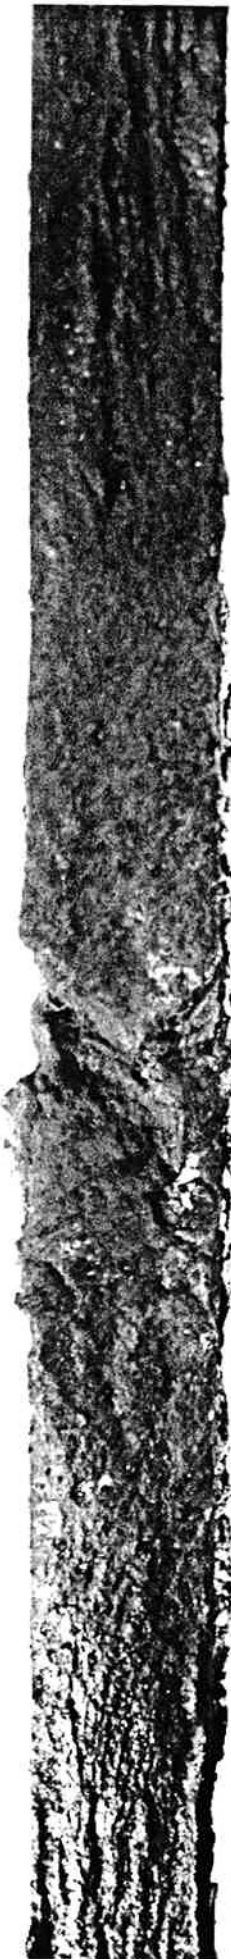
Photograph showing a weld deposit/splatter or arc gouge discontinuity in the fracture plane approximately midway between the bolt holes and the short edge of the plate. The lack of converging chevron-like marks near this discontinuity indicated it was not a primary fracture origin.

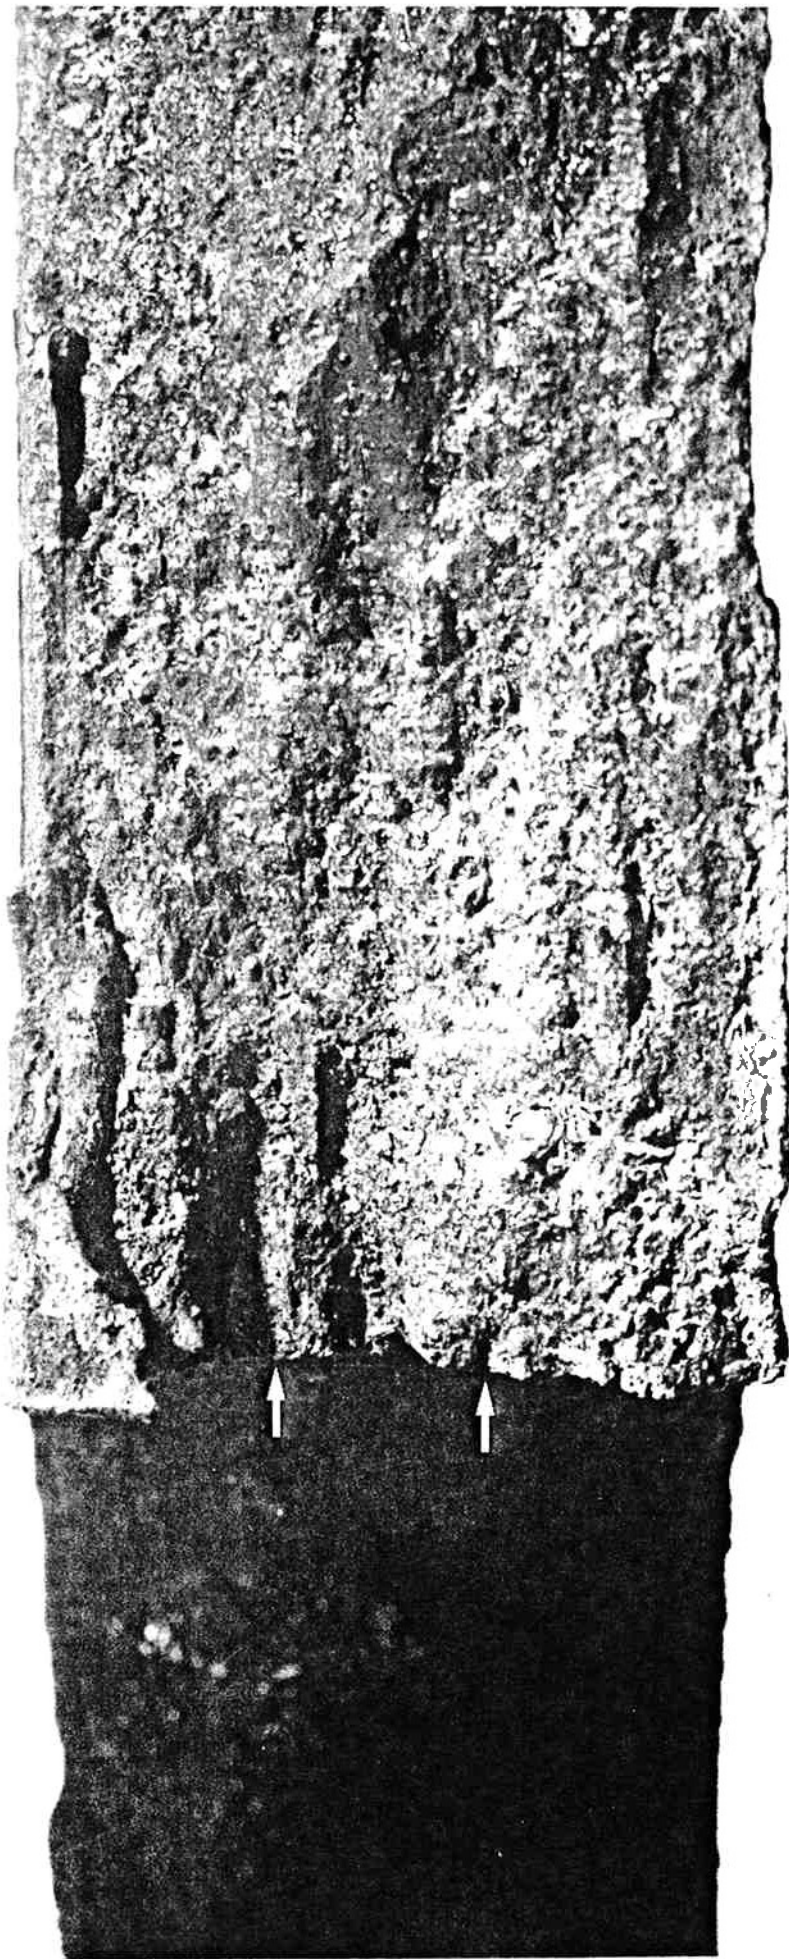
Close-up photograph showing the presence of fracture surface ratchet marks (arrows) at the bolt hole surfaces, as is characteristic of progressive crack initiation in the nature of fatigue.

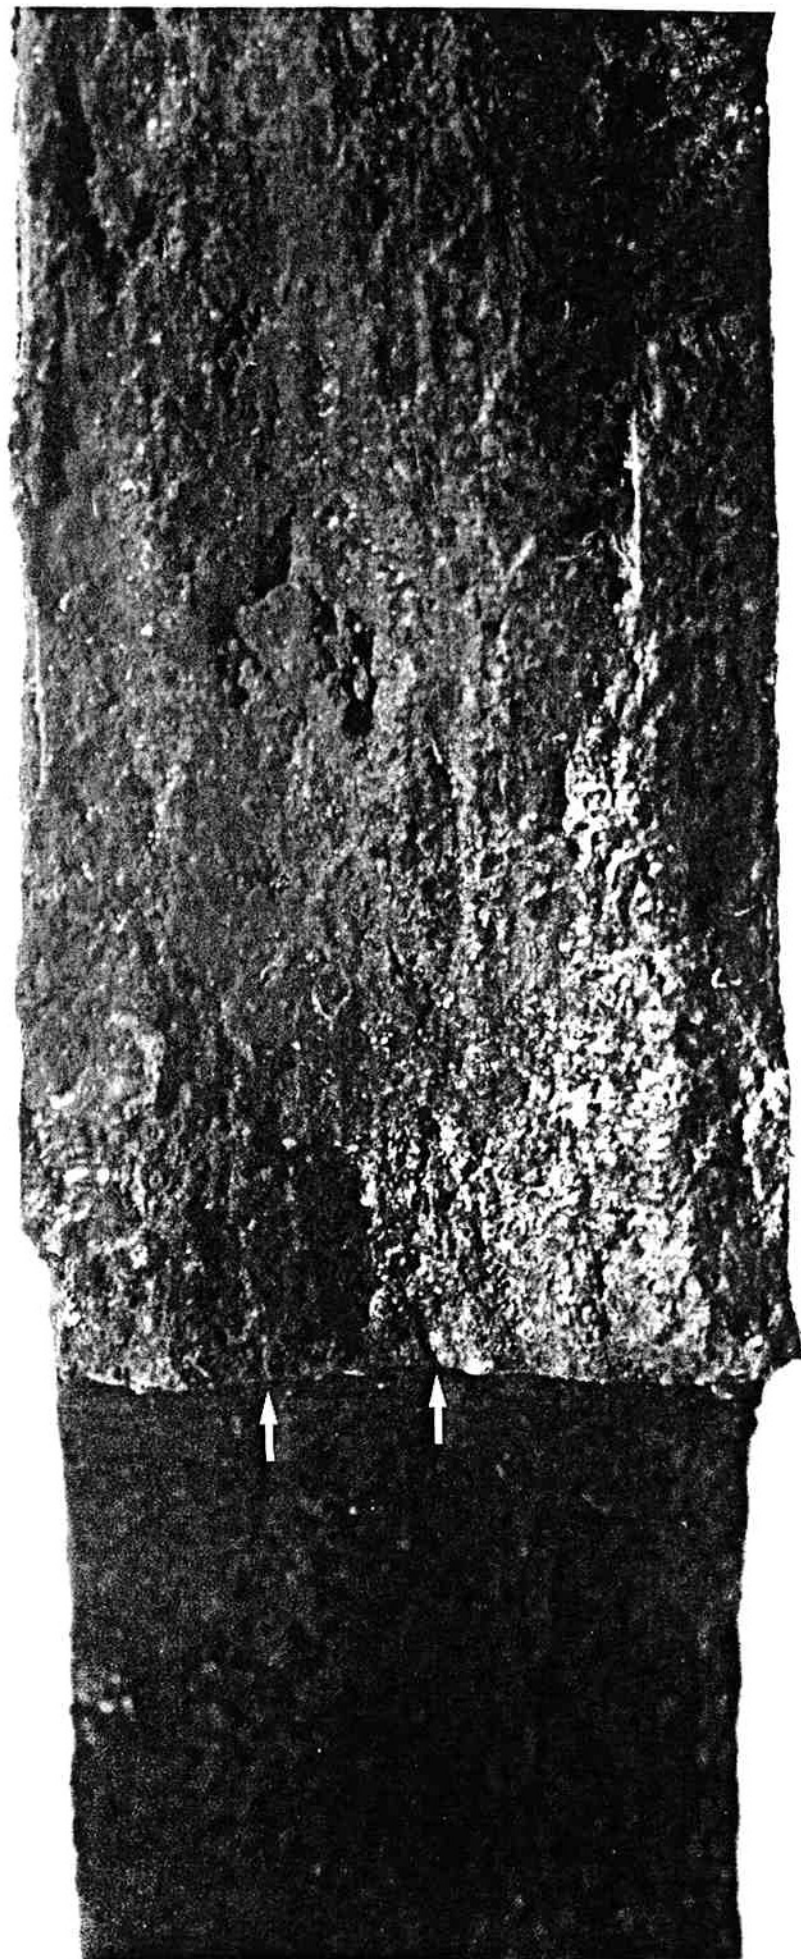
Close-up photograph showing the presence of fracture surface ratchet marks (arrows) at the bolt hole surfaces, as is characteristic of progressive crack initiation in the nature of fatigue.

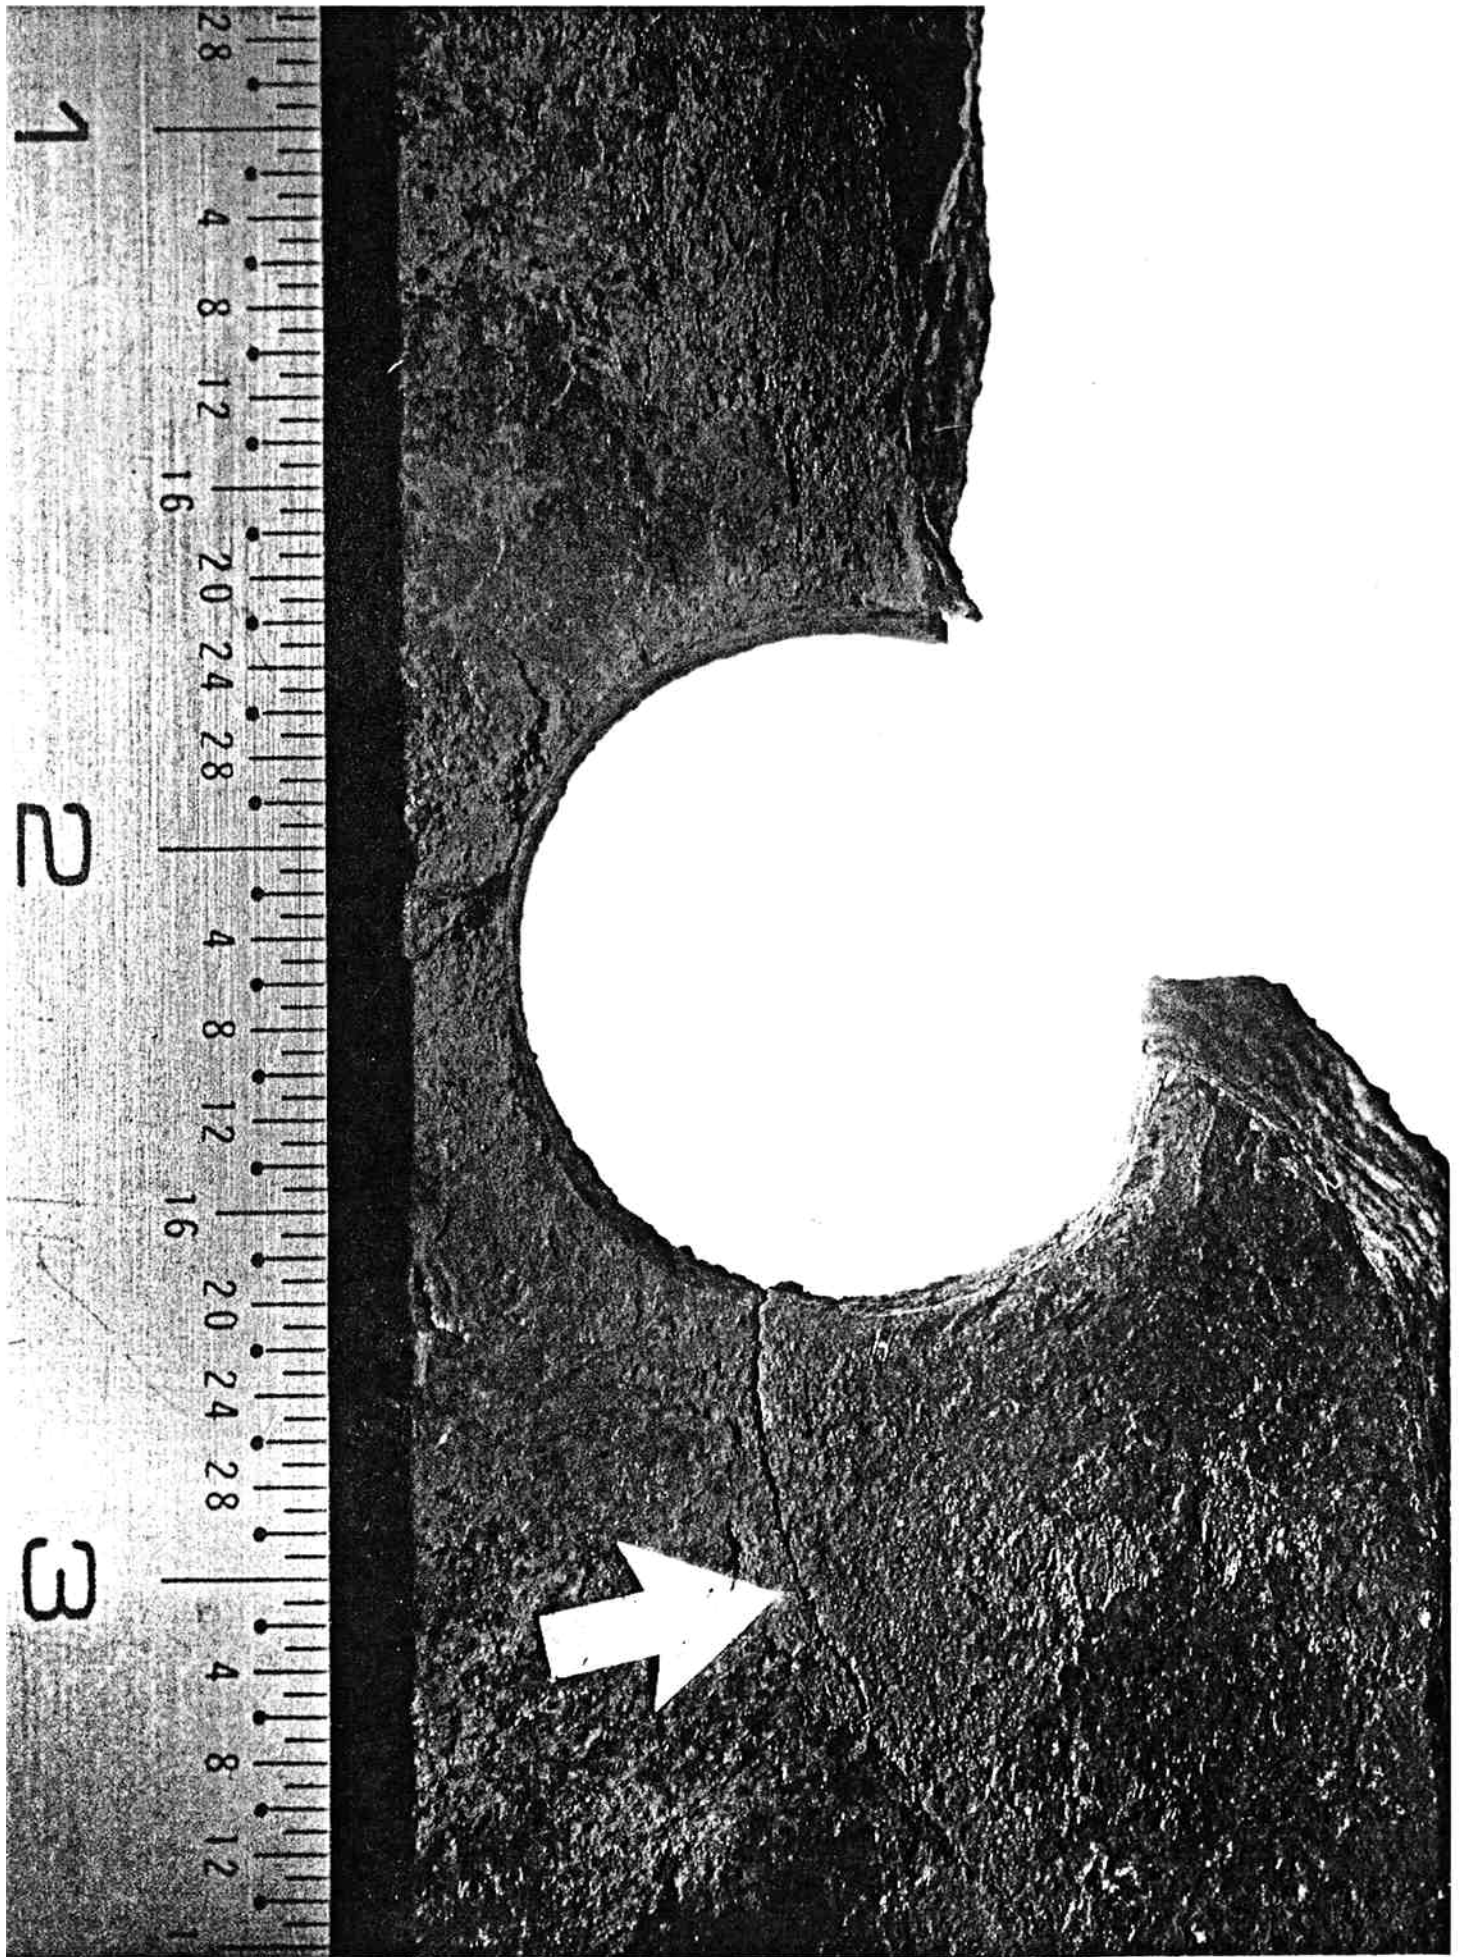
The results of the fractographic examination revealed secondary fatigue cracks also had originated at the bolt hole surfaces. The presence of secondary fatigue cracks at the bolt holes indicates the presence of intermediate to high cyclic stresses.

Close-up photograph showing a secondary fatigue crack (arrow) parallel and adjacent to the primary fracture, as is characteristic of fatigue cracking under intermediate to high cyclic stresses.
