II. EVENT RECONSTRUCTION

A. LCU Failure 2009-08-02 T22:43:00Z

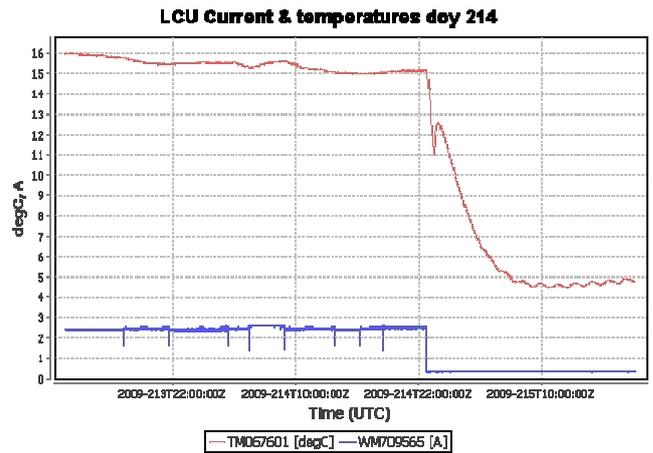
During DTCP (daily ground contact) of August 3rd (OD81) the LCU was found in an unknown mode 14 since 2009-08-02 T22:43:00Z (Fig. 3 and 4). From that moment on no response from the LCU to periodic HK requests (0xEEEE) and commands was received anymore (See Fig. 3). The LCU, LOU and LSU temperatures started to drop immediately. Spacecraft heaters were immediately switched on in an attempt to compensate the drop in temperature. The primary supply current dropped from 2.5A, corresponding to nominal operation of the LCU, to 0.36A from one to the next periodic HK reading, whereas the primary supply voltage remained constant all the time. The active band at the time of failure was band 7b tuned at a frequency of 1893.16 GHz in an on-the-fly mapping observing mode.

Fig. 4 Graphical illustration of the event recorded on OD-81. In blue the primary current consumption is shown, whereas the LCU temperature profile is indicated in red.

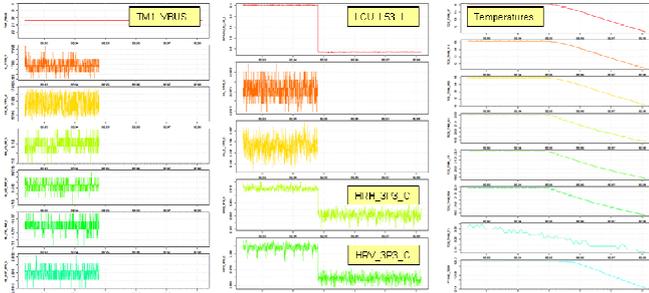
Inspection of the periodic LCU HK revealed that the LO power dropped from one to the next HK reading leaving the HEB mixer in an unpumped state (see Fig. 5). Prior to the event the conditions of the LO hardware as mimicked by the LCU HK were stable at the bit resolution level. The change occurred within one HK cycle of 4s. The drop in LO power was also confirmed by the HRS 3P3 current HK reading which is indicative of the IF power level of the mixer which in turn depends on the LO power received by the mixer. Just prior to the event the conditions at the LO hardware were completely stable (at the bit resolution level), reflected by very stable LCU analogue HK readings, primary supply current readings as well as HEB mixer and HRS 3P3 current HK readings. No action directed to the LO chain was going on at the time of the event.

Fig. 5 HK traces illustrating the sudden drop of primary supply current (top-middle) whereas the bus voltage remains unchanged (upper-left). The change of mixer current and IF power level was also detected by the HRS 3P3 current HK (IF processor). In the right column the change of temperatures following the event can be seen.

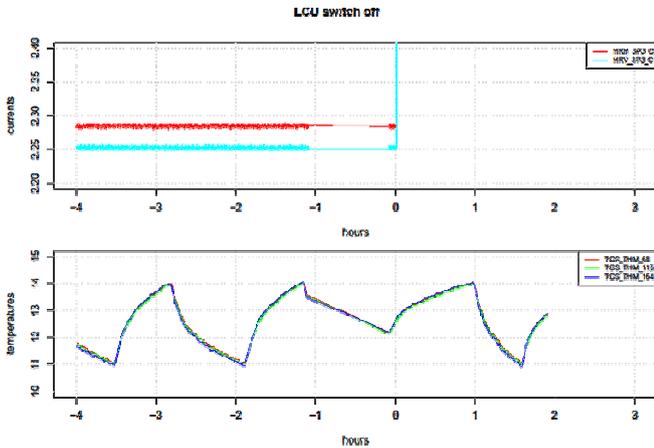
During DTCP of the 4th of August 2009 (OD83) the LCL for the LCU was opened removing the primary power from the unit. This was done in between the switching points of the thermal regulation cycle of the spacecraft. From the LCU and LSU temperature profiles with respect to time it was concluded that the dissipation of the LCU as well as the LSU had dropped. This was concluded on the basis of the changed temperature slope and duty cycle of the thermal regulation loop as shown in Fig. 6. When switching the LCU off the HRS 3P3 current increased from 2.2 to 2.6A yielding a

yellow flag for the HRS as can be seen in the upper plot of Fig. 6. In turn the HRS-H and -V were switched off as well. The increase of 3P3 current was assigned to the loss of the 10 MHz reference signal supplied by the LSU. HIFI was hence left in a hybrid state with the all units powered except for the LCU, LSU and HRS.

Fig. 6 Change of the HRS IF processor current consumption (3P3) and changed temperature profile of the LSU spacecraft panel when the LCU was switched off.

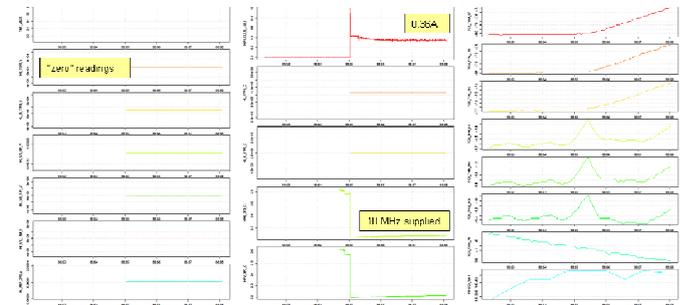
During DTCP of August 10th (OD89) a HIFI restart attempt was made. After closing the LCL for the LCU the primary supply current stabilized at 0.36A as shown in Fig. 7. The 10 MHz reference supplied by the LSU re-appeared reflected by the expected drop in the HRS 3P3 currents. Communication was fully restored and the LCU was found in standby mode after the boot procedure. The LCU checksum was in agreement with the expected value for the firmware (0x8D04) loaded from the on-board PROM confirming the integrity of the LCU memory. The analogue HK values were zero with a fixed raw value of 0x4000 in agreement with a non-powered ADC.

Fig. 7 HK charts centered on the HIFI restart attempt. In the left column "zero readings" of all analogue HK channels are shown. In the middle column the top plot the primary current consumption converges at 0.36A and the 10 MHz signal is provided again as shown by the 3P3 current profiles. In the right column the rising unit temperatures are shown.

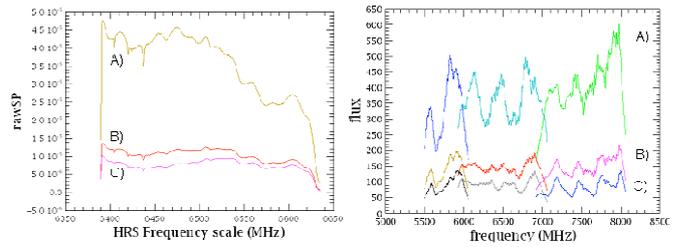
Making use of the data collected by the HIFI spectrometers during the integration interval where loss of LO power took place it could furthermore be reconstructed that permanent loss of communication happened 1.6s before the LO power was lost. The observing mode consisted of 3s integrations: 3 times 1s integrations for the HRS and one 3s integration for the WBS.

By considering the total power in an IF spectrum for A) a fully pumped mixer prior to the event, B) an integration during which drop of LO power occurred and C) a fully underpumped mixer after the event a linear interpolation scheme was used to reconstruct the time of the event relative to the start of the integration sequence (see Fig. 9). For the WBS as well as the HRS a consistent number of 1.58s was found. The validity of the method was verified by using the lab setup consisting of the QM/IMD-3 LCU unit, a so-called subsystem bus monitor which was used to monitor and trigger on traffic on the serial interface between the ICU and control units and a noise source connected to a fast switch.

We therefore came to the important conclusion that the whole sequence of events connected to the LCU failure started with loss of communication and only 1.6s later with loss of LO power. This strongly suggested that loss of communication was not caused by a failure and reversed the intuitive order of cause and effect.

Fig. 9 Raw HRS and WBS spectra corresponding to A) fully pumped mixer, B) integration during which failure occurred and C) completely underpumped mixer.

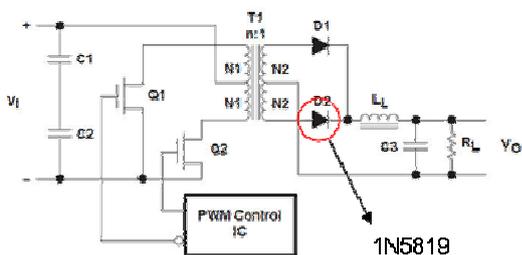
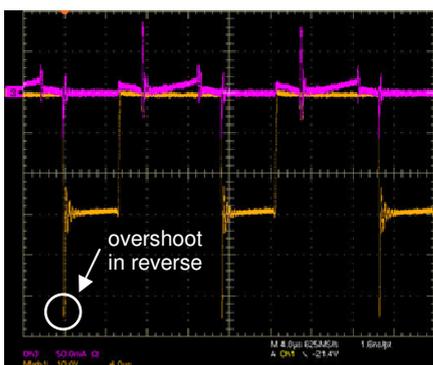
In Fig. 10 we show the secondary diode configuration. Diodes D1 and D2 are of type 1N5819. It was found that the leakage inductance of the transformer in series with the diode capacitance formed a resonant LC circuit resulting in a very short spike/overshoot every time the diodes switch from forward conduction to reverse operation. The 16 diodes in the HRS-4 converter are nominally subjected to reverse voltage peaks of $\sim 54V$, while their absolute maximum reverse voltage is specified as 45V. The duration of the voltage peaks is ~ 50 ns at a repetition rate of 65 kHz (0.3% duty cycle).

Fig. 10 Reverse voltage overshoot across the 1N5819 secondary rectifier diode.

The level of the peak voltage only depends on the input voltage of the HRS-4 converter. This voltage is usually 27V due to voltage loss across cables and LCU Ripple Filter. An overshoot on the HRS-4 input voltage occurs when the

current drawn by the LO subsystem changes significantly (i.e. during mode transitions, band changes, etc). Generally these overshoots are about 2V (planned cases), only in case of a sudden transition from nominal to stand-by mode (unplanned) the overshoot can be as high as 4V. The voltage peaks across the diodes reach 58V or 62V respectively.

Tests performed on a limited number of diodes showed an average reverse breakdown voltage of 59V, so it is likely that breakdown occurs during such changes in LO subsystem activity. Breakdown is considered as the primary cause for damage and ultimately failure of these diodes.

- Reduce load steps, avoid significant and unnecessary primary current transients associated with instrument mode transitions by changing the operational procedures and a modified LCU state definition
- Avoid a cold start of the LCU, operate the unit between 10 and 30°C to keep the stress on the rectifier diodes within tested ranges
- Disable the LCU program code that can switch the standby relay after execution of the boot procedure
- Perform explicit and regular checksum calculations after each observation verifying the integrity of the LCU memory in order to timely capture a SEU. Abort operations when a corruption is detected.

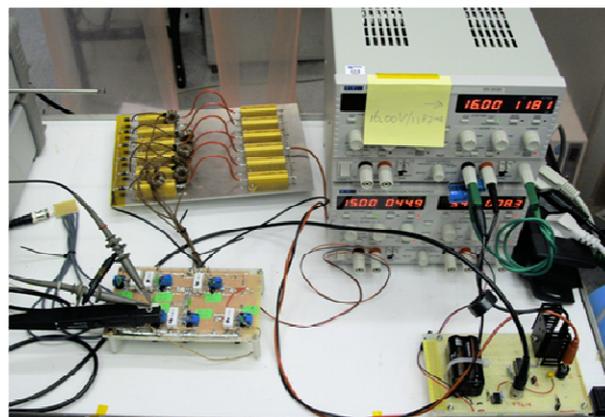
For that reasons dedicated component level tests have been performed on representative flight quality devices (see Fig. 11). An endurance test of over 2000 hrs with short repetitive reverse current pulses up to 1A avalanche current did not kill any Schottky diode. On the other hand tests on commercial diodes immediately killed one device at only moderate conditions whereas another could not be killed at all. All of this suggests a failure mode in which the reverse current finds a local destructive path in contrary to a global thermal breakdown of the entire junction. Evidence was furthermore found in literature that the failure mechanism is threshold driven and can be avoided by reverse energy screening of flight devices.

Fig. 11 Repetitive pulsed-stress setup addressing failure mechanism of 1N5819 diodes.
