The HIFI OD-81 Anomaly

Abstract— On Monday 3rd of August 2009 the Mission Operation Center (MOC) reported that Herschel-HIFI was found in an undocumented state since 22:43Z on August 2nd during otherwise nominal execution of a red-shifted C+ observation in band 7b. The instrument no longer responded to HK requests and commands for the LO subsystem and communication between the Instrument Control Unit (ICU) and the Local Oscillator Control Unit (LCU) had clearly been lost. At the same time the HEB mixer in band 7 had changed from a nominally pumped to a completely under-pumped state and the primary power consumption of the LCU had dropped from a nominal current of 2.5A to 0.36A only.

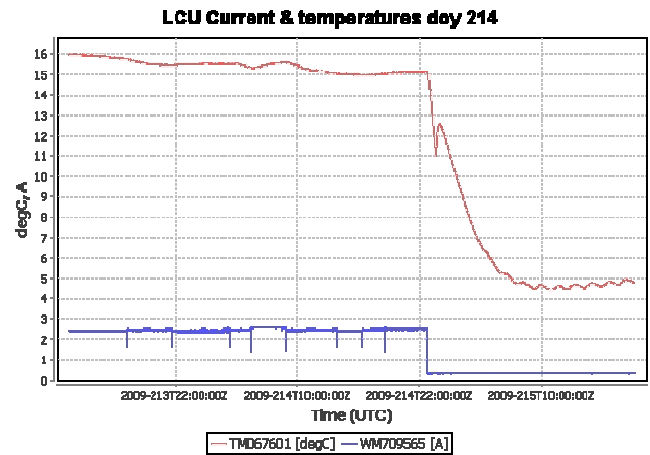
During DTCP (daily ground contact) of August 3rd (OD81) the LCU was found in an unknown mode 14 since 2009-08-02 T22:43:00Z (Fig. 3 and 4). From that moment on no response from the LCU to periodic HK requests (0xEEEE) and commands was received anymore (See Fig. 3). The LCU, LOU and LSU temperatures started to drop immediately. Spacecraft heaters were immediately switched on in an attempt to compensate the drop in temperature. The primary supply current dropped from 2.5A, corresponding to nominal operation of the LCU, to 0.36A from one to the next periodic HK reading, whereas the primary supply voltage remained constant all the time. The active band at the time of failure was band 7b tuned at a frequency of 1893.16 GHz in an on-the-fly mapping observing mode.

Fig. 4 Graphical illustration of the event recorded on OD-81. In blue the primary current consumption is shown, whereas the LCU temperature profile is indicated in red.

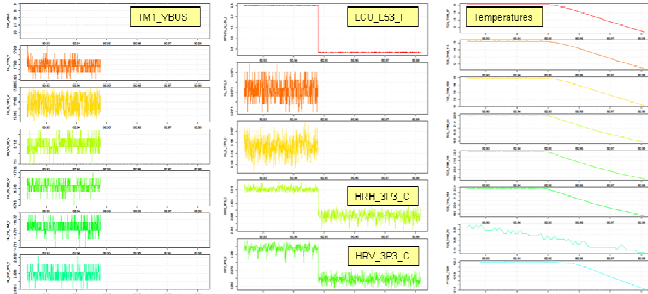
Inspection of the periodic LCU HK revealed that the LO power dropped from one to the next HK reading leaving the HEB mixer in an unpumped state (see Fig. 5). Prior to the event the conditions of the LO hardware as mimicked by the LCU HK were stable at the bit resolution level. The change occurred within one HK cycle of 4s. The drop in LO power was also confirmed by the HRS 3P3 current HK reading which is indicative of the IF power level of the mixer which in turn depends on the LO power received by the mixer. Just prior to the event the conditions at the LO hardware were completely stable (at the bit resolution level), reflected by very stable LCU analogue HK readings, primary supply current readings as well as HEB mixer and HRS 3P3 current HK readings. No action directed to the LO chain was going on at the time of the event.

Fig. 5 HK traces illustrating the sudden drop of primary supply current (top-middle) whereas the bus voltage remains unchanged (upper-left). The change of mixer current and IF power level was also detected by the HRS 3P3 current HK (IF processor). In the right column the change of temperatures following the event can be seen.

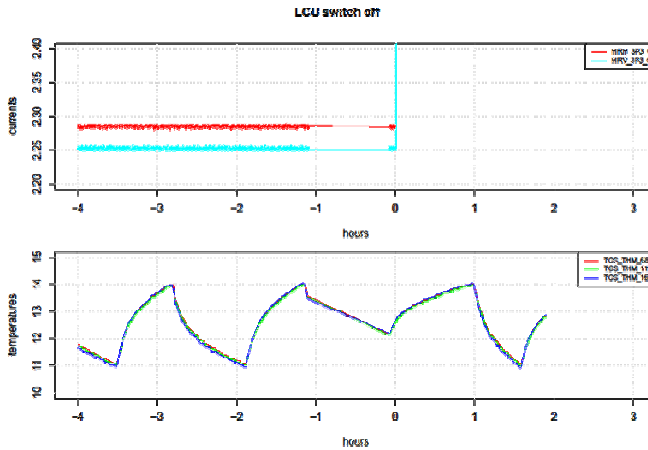
yellow flag for the HRS as can be seen in the upper plot of Fig. 6. In turn the HRS-H and -V were switched off as well. The increase of 3P3 current was assigned to the loss of the 10 MHz reference signal supplied by the LSU. HIFI was hence left in a hybrid state with the all units powered except for the LCU, LSU and HRS.

Fig. 6 Change of the HRS IF processor current consumption (3P3) and changed temperature profile of the LSU spacecraft panel when the LCU was switched off.

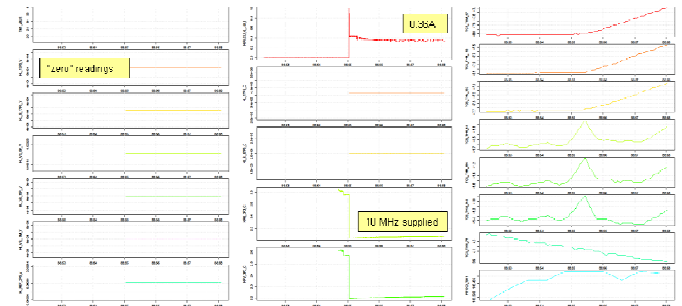
During DTCP of August 10th (OD89) a HIFI restart attempt was made. After closing the LCL for the LCU the primary supply current stabilized at 0.36A as shown in Fig. 7. The 10 MHz reference supplied by the LSU re-appeared reflected by the expected drop in the HRS 3P3 currents. Communication was fully restored and the LCU was found in standby mode after the boot procedure. The LCU checksum was in agreement with the expected value for the firmware (0x8D04) loaded from the on-board PROM confirming the integrity of the LCU memory. The analogue HK values were zero with a fixed raw value of 0x4000 in agreement with a non-powered ADC.

Fig. 7 HK charts centered on the HIFI restart attempt. In the left column "zero readings" of all analogue HK channels are shown. In the middle column the top plot the primary current consumption converges at 0.36A and the 10 MHz signal is provided again as shown by the 3P3 current profiles. In the right column the rising unit temperatures are shown.

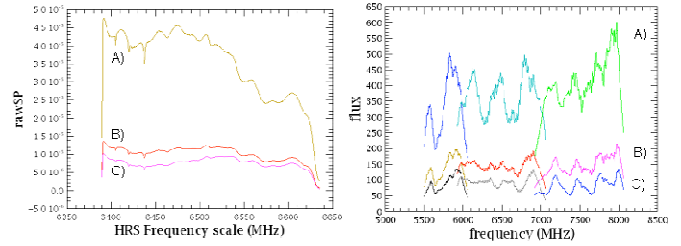
We therefore came to the important conclusion that the whole sequence of events connected to the LCU failure started with loss of communication and only 1.6s later with loss of LO power. This strongly suggested that loss of communication was not caused by a failure and reversed the intuitive order of cause and effect.

Fig. 9 Raw HRS and WBS spectra corresponding to A) fully pumped mixer, B) integration during which failure occurred and C) completely underpumped mixer.

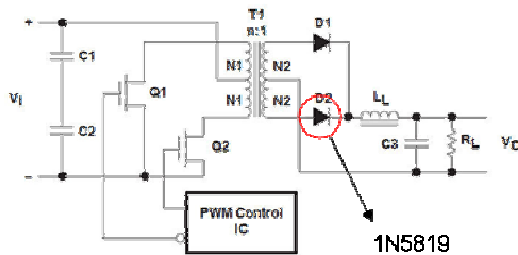
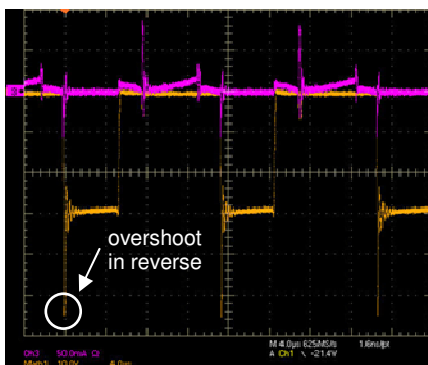
In Fig. 10 we show the secondary diode configuration. Diodes D1 and D2 are of type 1N5819. It was found that the leakage inductance of the transformer in series with the diode capacitance formed a resonant LC circuit resulting in a very short spike/overshoot every time the diodes switch from forward conduction to reverse operation. The 16 diodes in the HRS-4 converter are nominally subjected to reverse voltage peaks of $\sim 54V$, while their absolute maximum reverse voltage is specified as $45V$. The duration of the voltage peaks is ~ 50 ns at a repetition rate of 65 kHz (0.3% duty cycle).

Fig. 10 Reverse voltage overshoot across the 1N5819 secondary rectifier diode.

current drawn by the LO subsystem changes significantly (i.e. during mode transitions, band changes, etc). Generally these overshoots are about $2V$ (planned cases), only in case of a sudden transition from nominal to stand-by mode (unplanned) the overshoot can be as high as $4V$. The voltage peaks across the diodes reach $58V$ or $62V$ respectively.

Tests performed on a limited number of diodes showed an average reverse breakdown voltage of $59V$, so it is likely that breakdown occurs during such changes in LO subsystem activity. Breakdown is considered as the primary cause for damage and ultimately failure of these diodes.

- Reduce load steps, avoid significant and unnecessary primary current transients associated with instrument mode transitions by changing the operational procedures and a modified LCU state definition
- Avoid a cold start of the LCU, operate the unit between 10 and 30°C to keep the stress on the rectifier diodes within tested ranges
- Disable the LCU program code that can switch the standby relay after execution of the boot procedure
- Perform explicit and regular checksum calculations after each observation verifying the integrity of the LCU memory in order to timely capture a SEU. Abort operations when a corruption is detected.

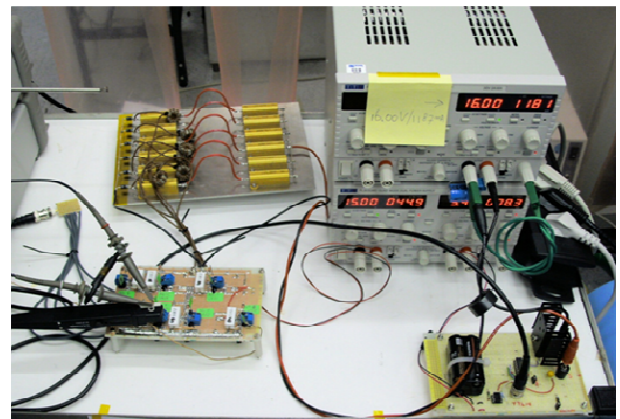
For that reasons dedicated component level tests have been performed on representative flight quality devices (see Fig. 11). An endurance test of over 2000 hrs with short repetitive reverse current pulses up to $1A$ avalanche current did not kill any Schottky diode. On the other hand tests on commercial diodes immediately killed one device at only moderate conditions whereas another could not be killed at all. All of this suggests a failure mode in which the reverse current finds a local destructive path in contrary to a global thermal breakdown of the entire junction. Evidence was furthermore found in literature that the failure mechanism is threshold driven and can be avoided by reverse energy screening of flight devices.

Fig. 11 Repetitive pulsed-stress setup addressing failure mechanism of 1N5819 diodes.
