REPORT
OF THE
TECHNICAL ASSESSMENT PANEL

COLLAPSE OF THE 300 foot RADIO TELESCOPE

**REPORT of the TECHNICAL ASSESSMENT PANEL
for the
300 foot RADIO TELESCOPE at GREEN BANK, WV**

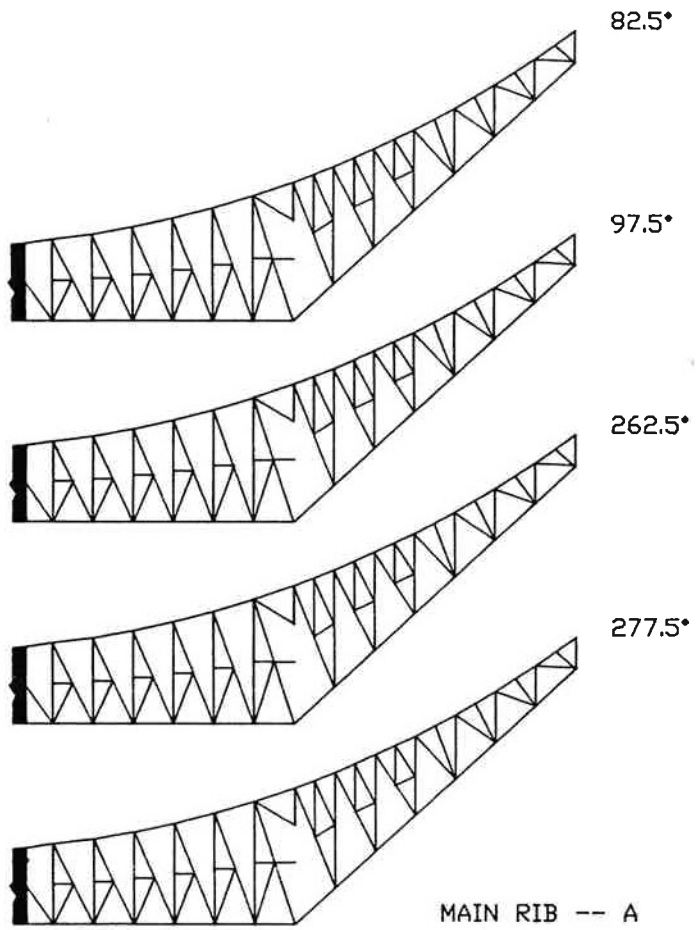
OVERSTRESSED MEMBERS
per AISC CODE EIGHTH
EDITION:

FIGURE NO. 2-12
 300 FT. RADIO TELESCOPE
 GREEN BANK, WVa.
 MAIN RIBS, A & D
 MEMBER OVERSTRESSES,
 ZENITH POSITION

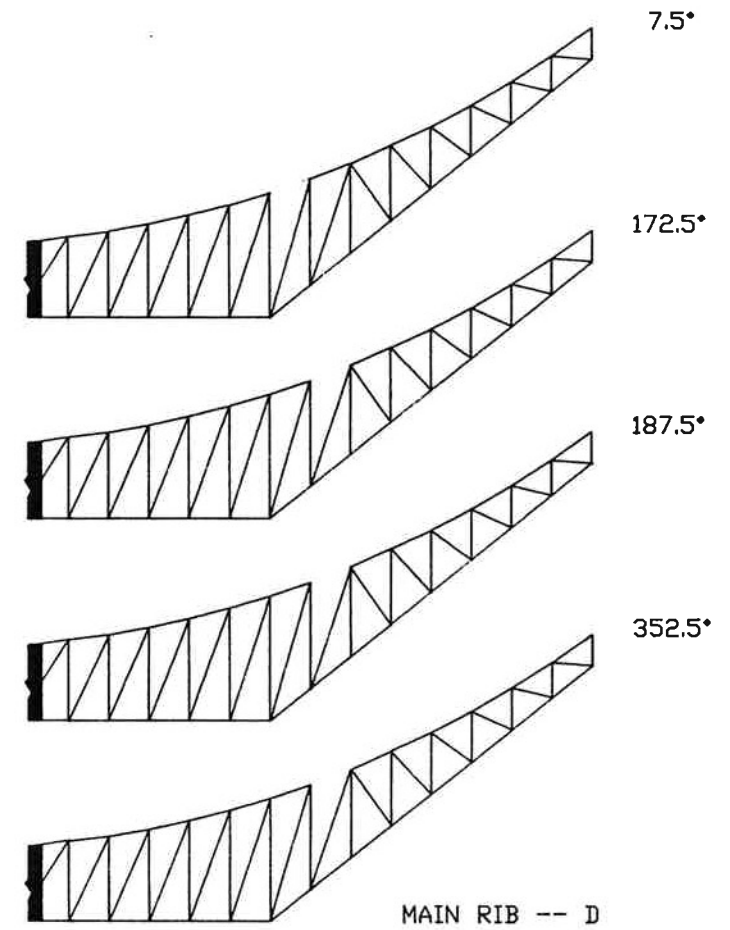
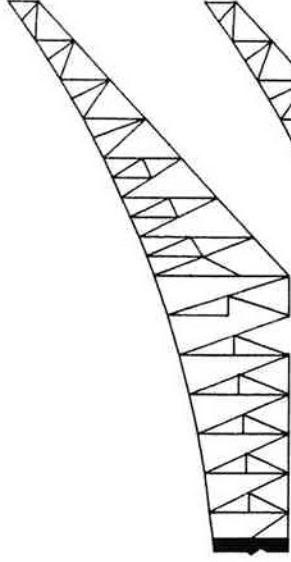
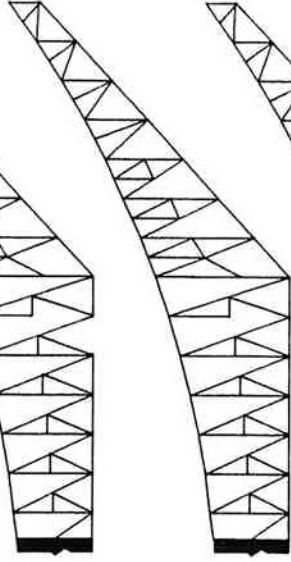
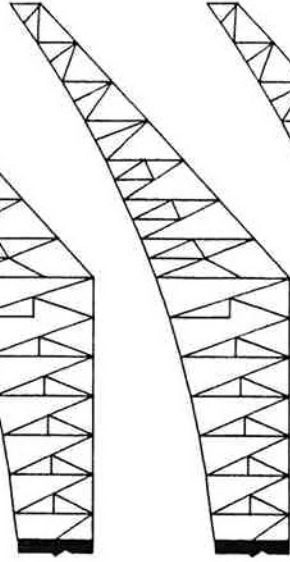
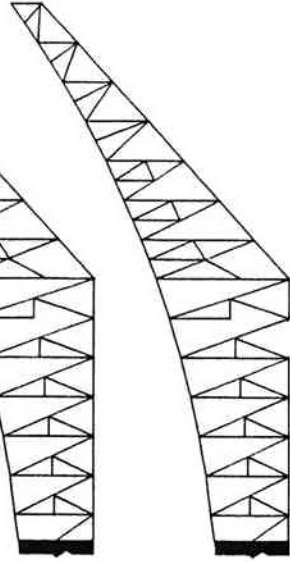
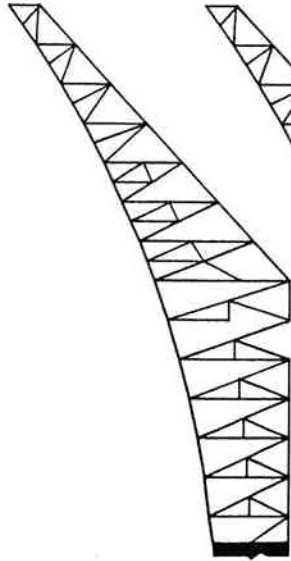
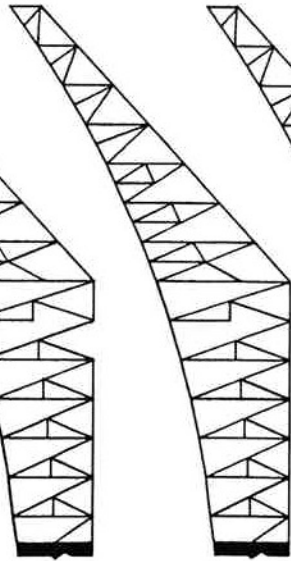
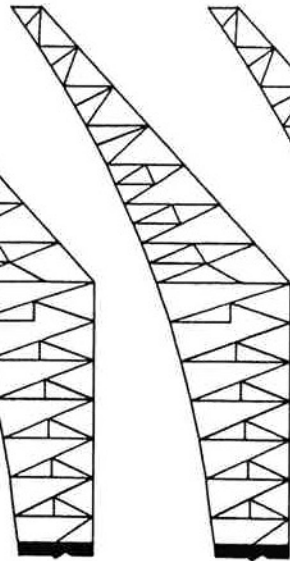
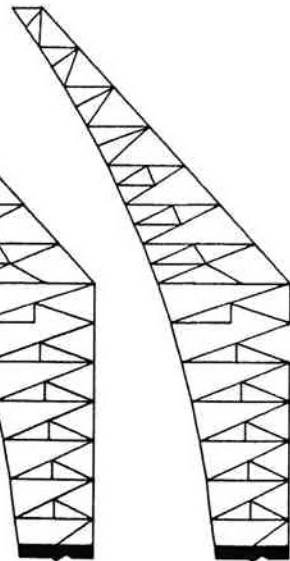
OVERSTRESSED MEMBERS
per AISC CODE EIGHTH
EDITION:

FIGURE NO. 2-13
300 FT. RADIO TELESCOPE
GREEN BANK, W.Va.
MAIN RIBS, B
MEMBER OVERSTRESSES,
ZENITH POSITION

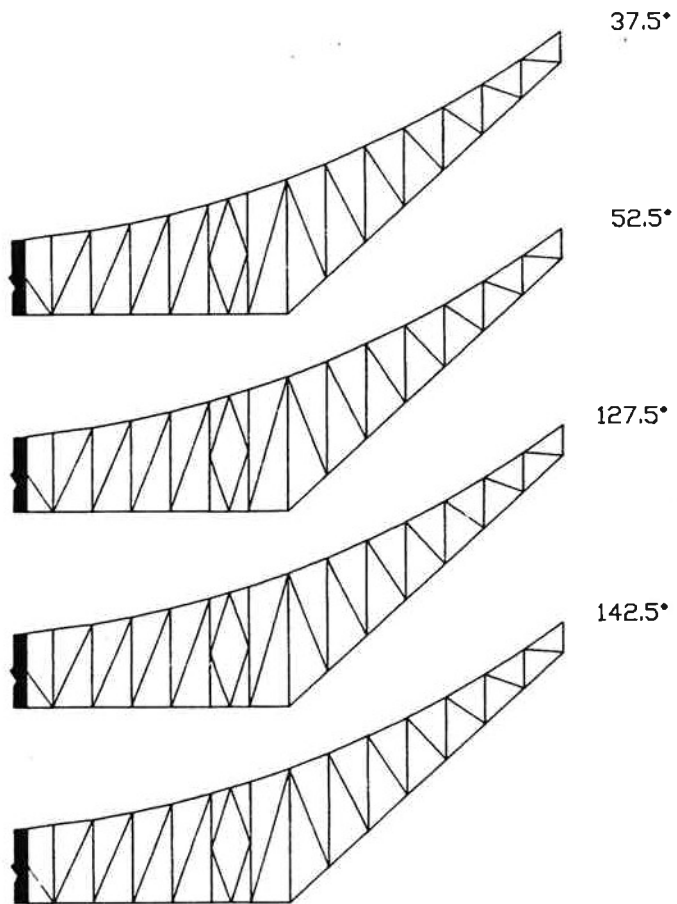
NOTE:
NO OVERSTRESSES
DETERMINED

FIGURE NO. 2-14
300 FT. RADIO TELESCOPE
GREEN BANK, WV. a.
MAIN RIBS C
MEMBER OVERSTRESSES,
ZENITH & 45° INCLINED
DISH POSITIONS

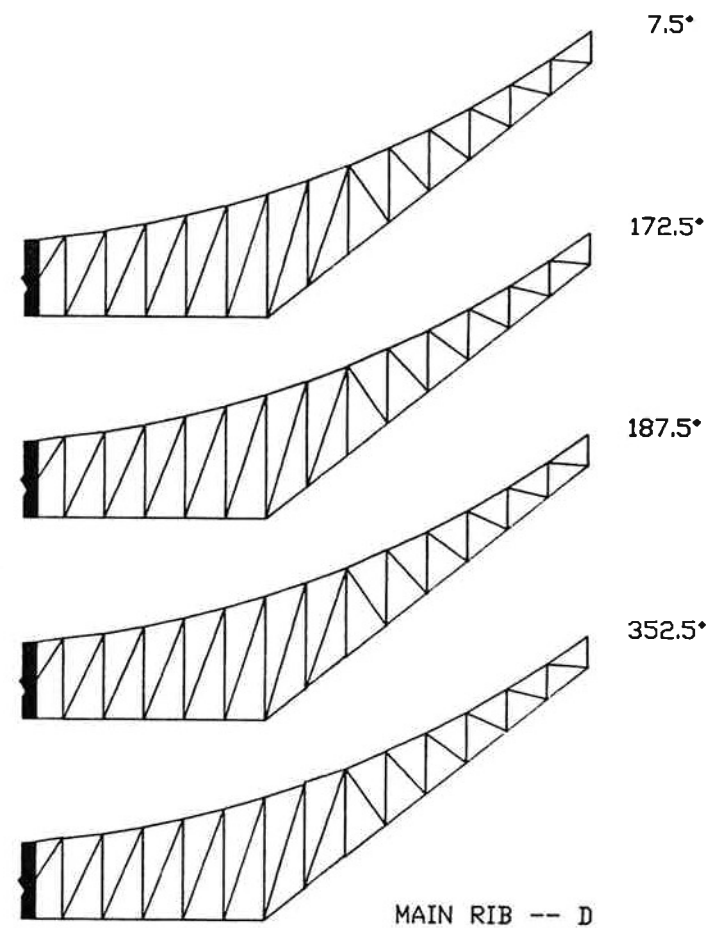
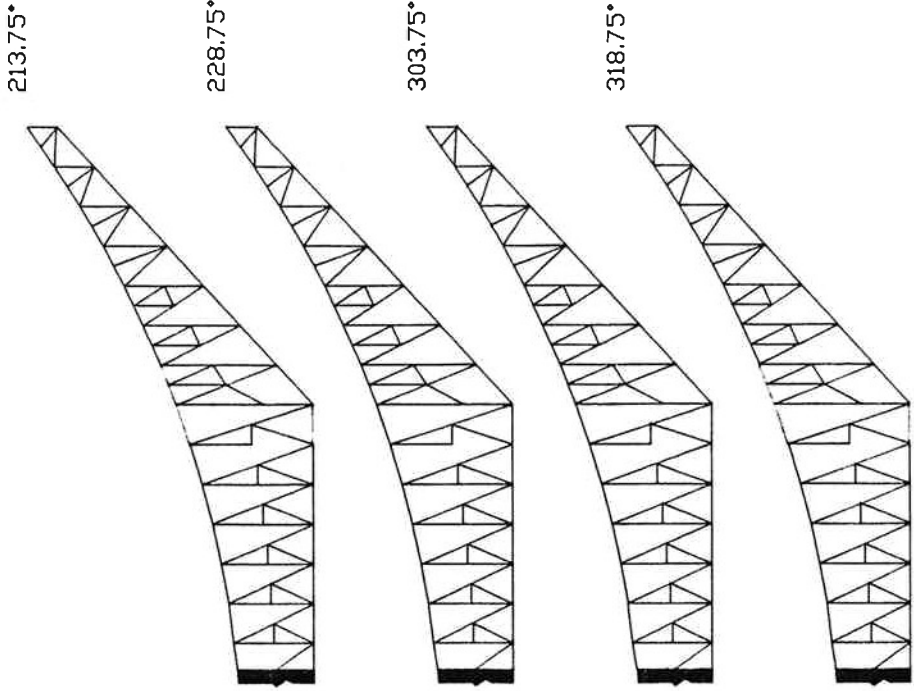
FIGURE NO. 2-15
 300 FT. RADIO TELESCOPE
 GREEN BANK, WV.
 MAIN RIBS, A & D
 MEMBER OVERSTRESSES,
 45° INCLINED DISH POSITION

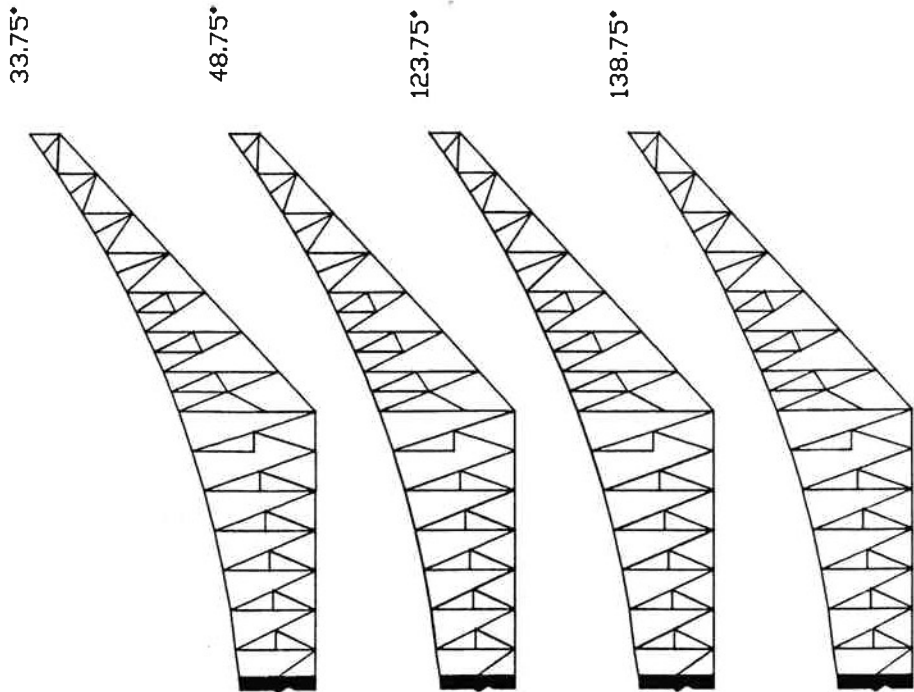
FIGURE NO. 2-16
RADIO TELESCOPE
GREEN BANK, WV^a.
MAIN RIBS, B
MEMBER OVERSTRESSES,
45° INCLINED DISH POSITION

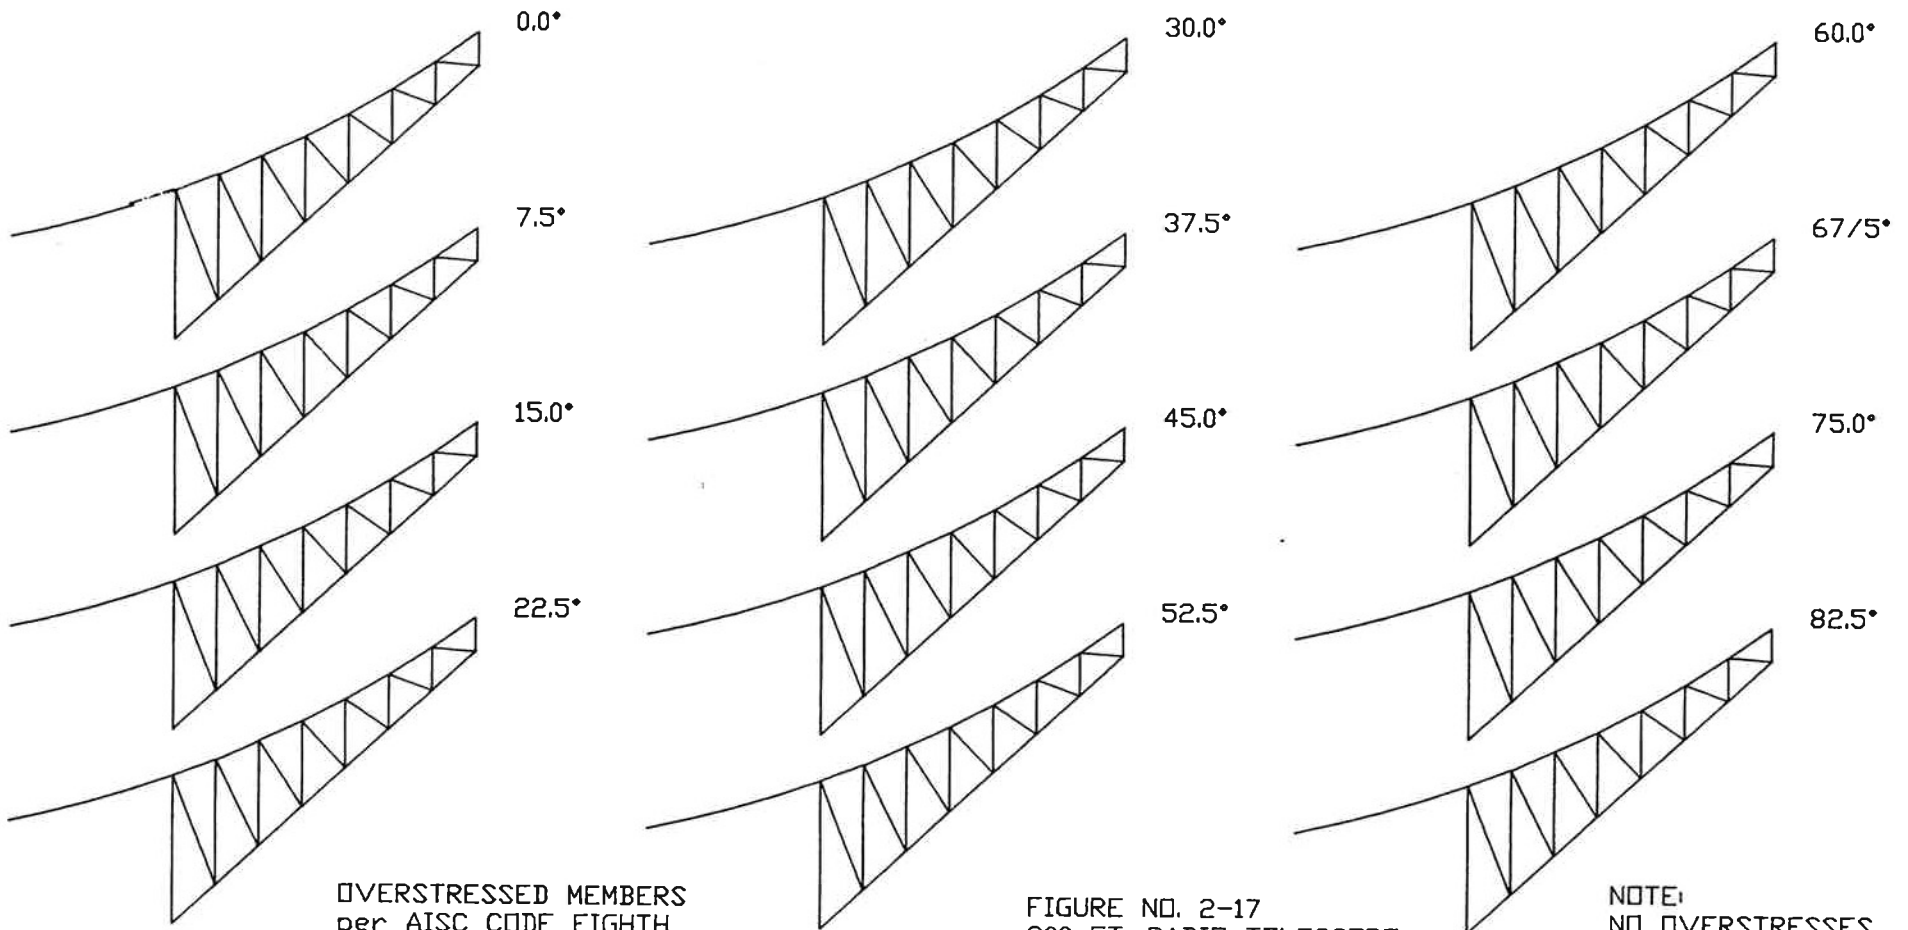
FIGURE NO. 2-17
 300 FT. RADIO TELESCOPE
 GREEN BANK, WV_a.
 AUXILIARY RIBS
 MEMBER OVERSTRESSES,
 ZENITH & 45° INCLINED
 DISH POSITIONS

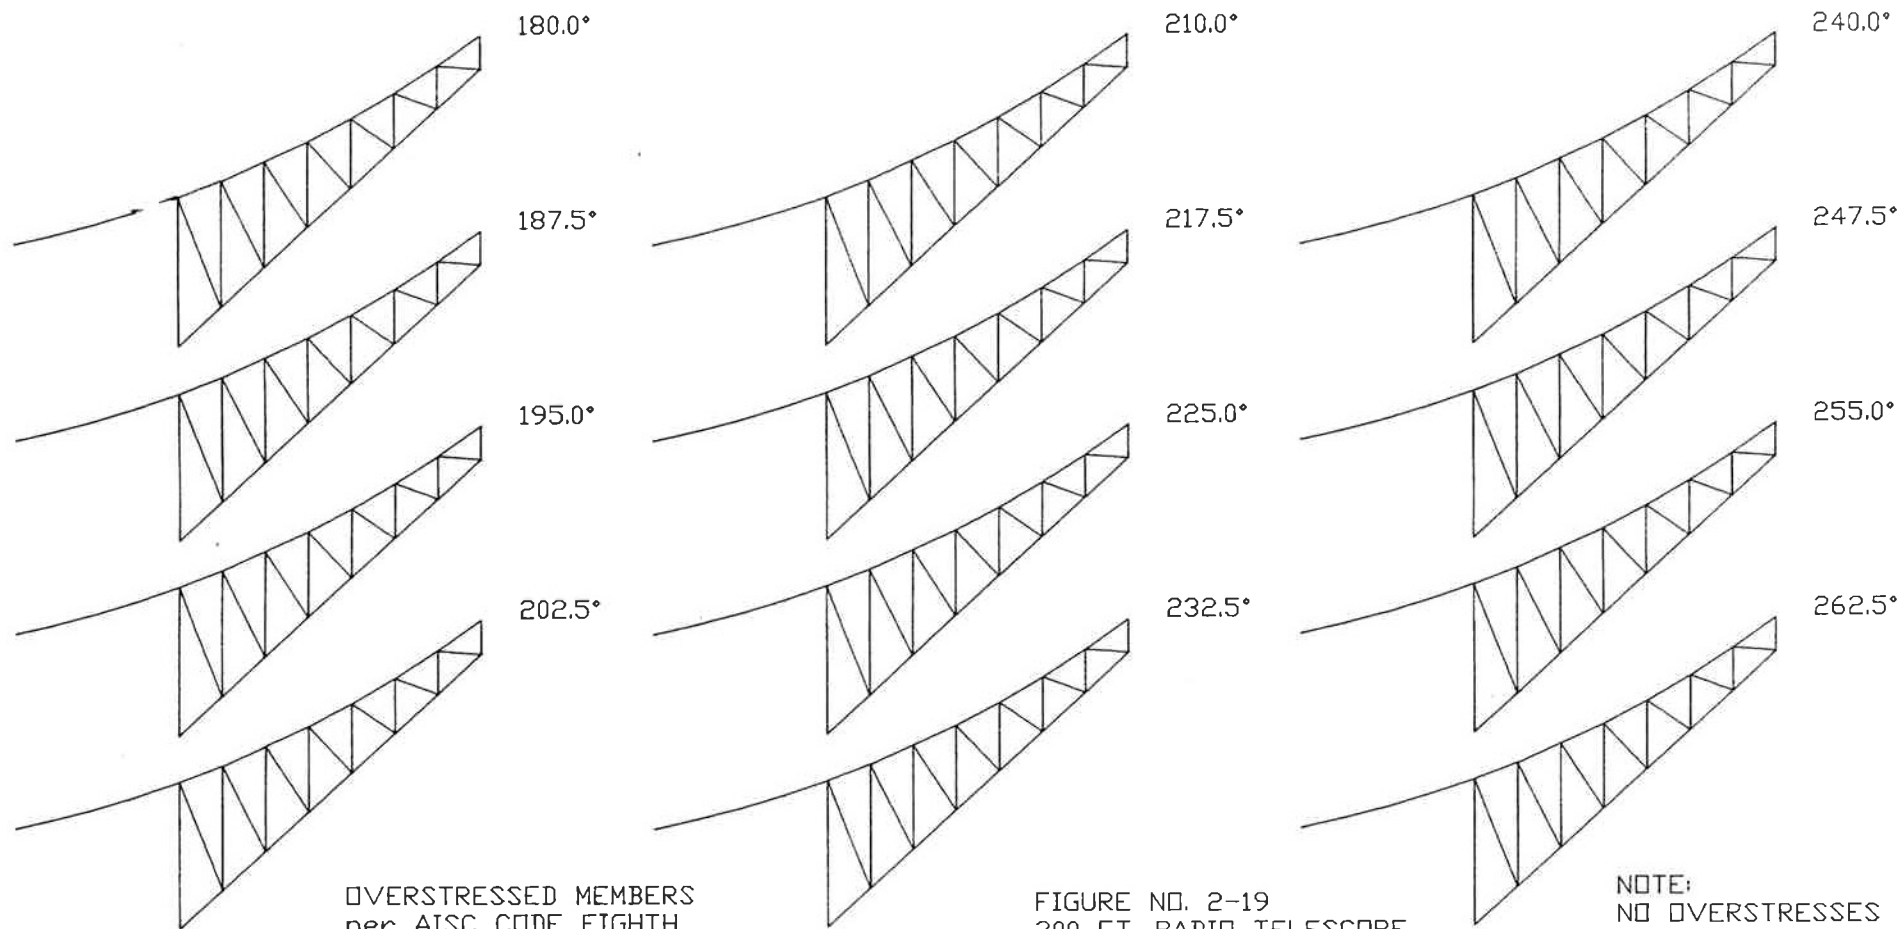
FIGURE NO. 2-19
 300 FT. RADIO TELESCOPE
 GREEN BANK, WV_a.
 AUXILIARY RIBS
 MEMBER OVERSTRESSES,
 ZENITH & 45° INCLINED
 DISH POSITIONS

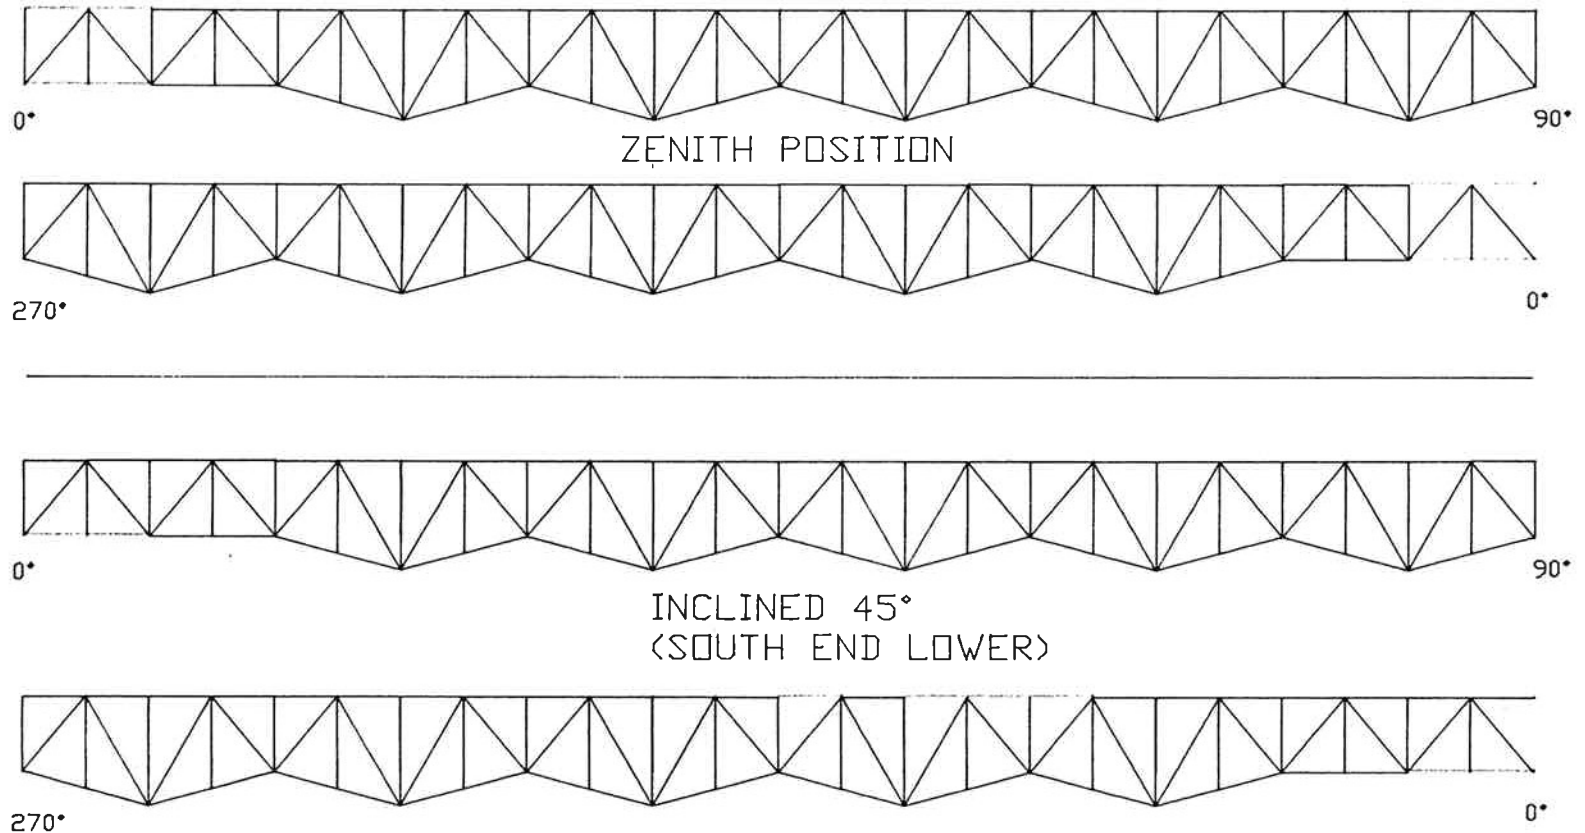
FIGURE NO. 2-24
 300 FT. RADIO TELESCOPE
 GREEN BANK, WVa.
 CIRCUMFERENCE 4,
 MEMBER OVERSTRESSES,
 ZENITH & 45° INCLINED
 DISH POSITIONS

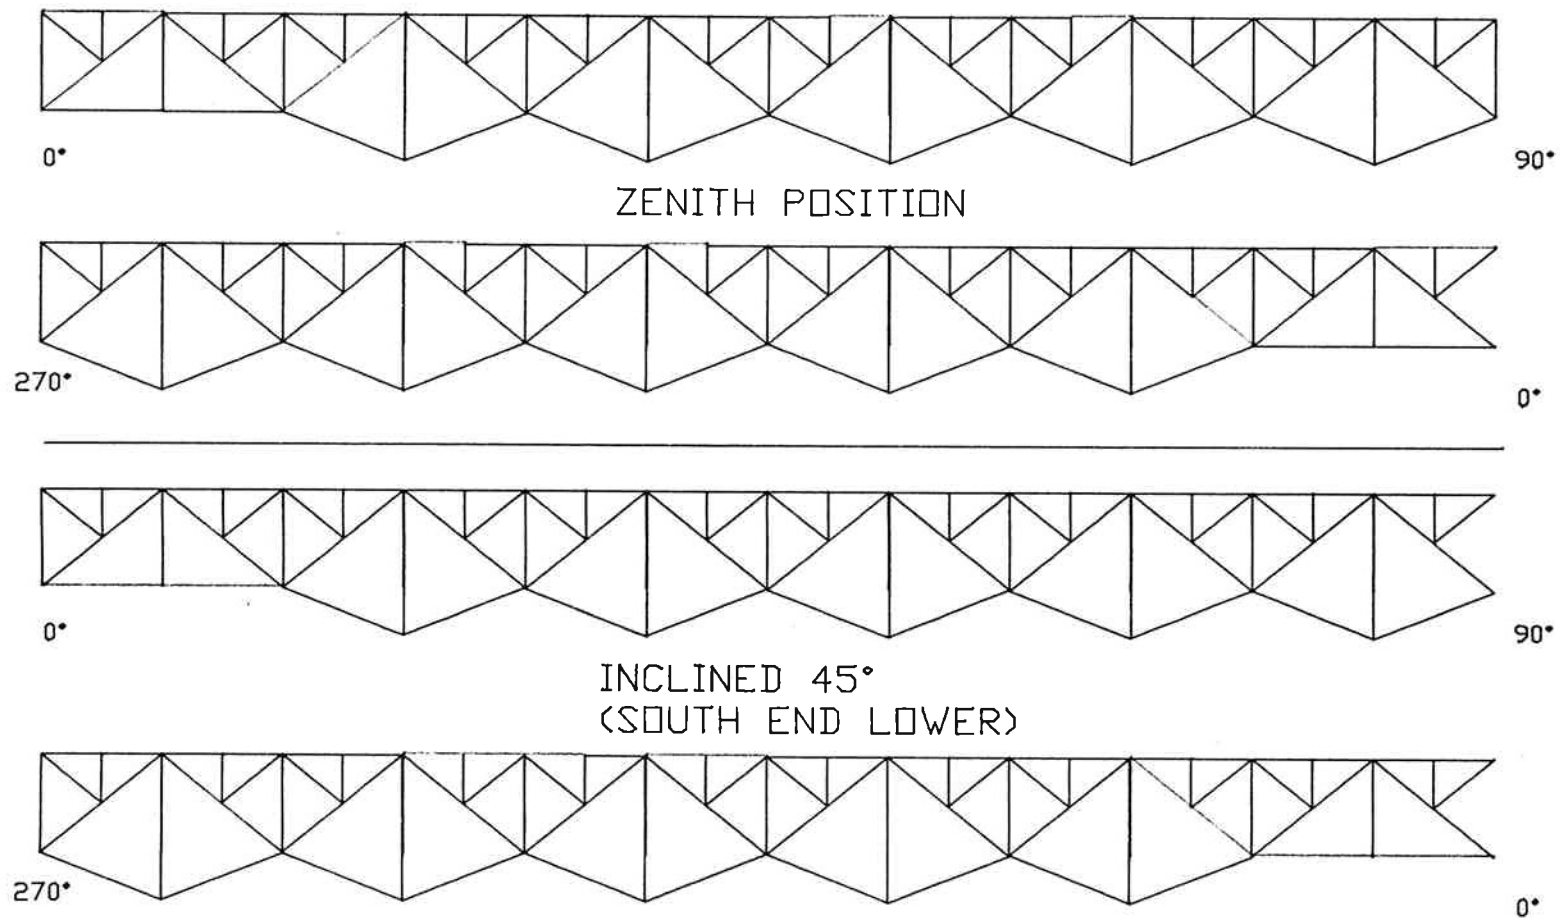
FIGURE NO. 2-25
 300 FT. RADIO TELESCOPE
 GREEN BANK, WV.
 CIRCUMFERENCE 5,
 MEMBER OVERSTRESSES
 ZENITH & 45° INCLINED
 DISH POSITIONS

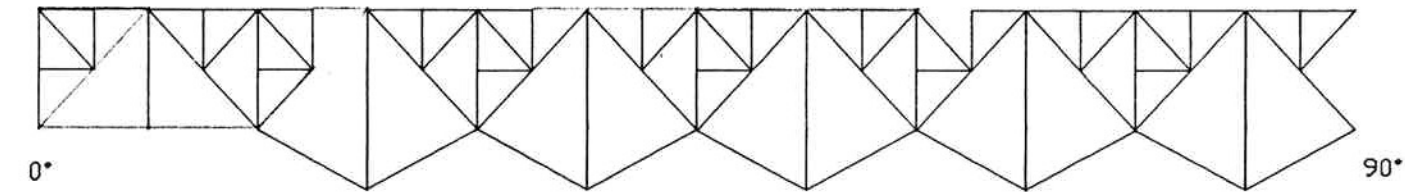
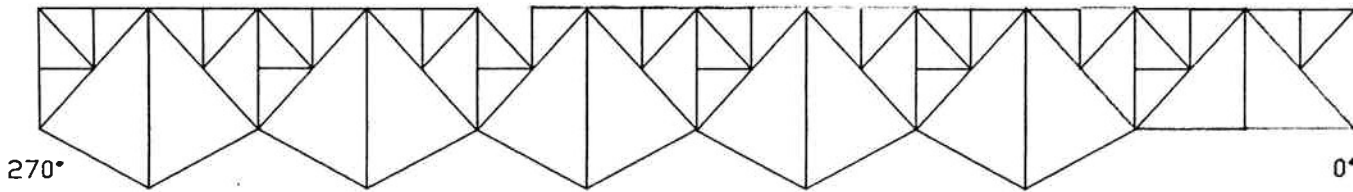
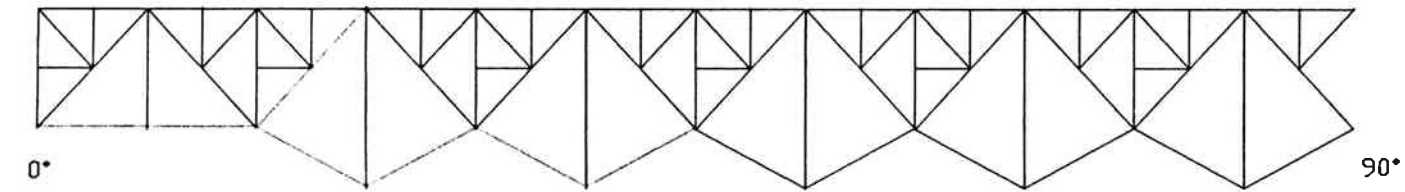
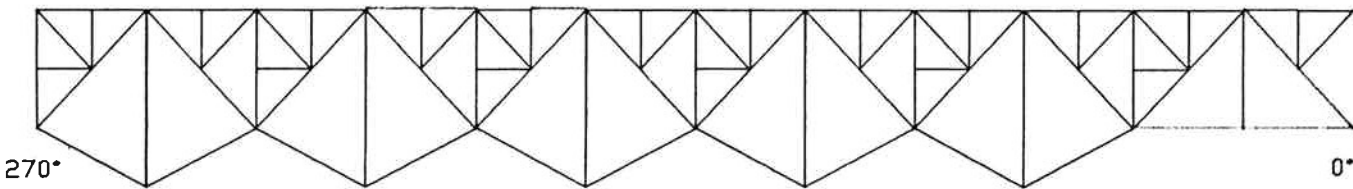
FIGURE NO. 2-26
300 FT. RADIO TELESCOPE
GREEN BANK, WV, a.
CIRCUMFERENCE 6,
MEMBER OVERSTRESSES,
ZENITH & 45° INCLINED
DISH POSITIONS

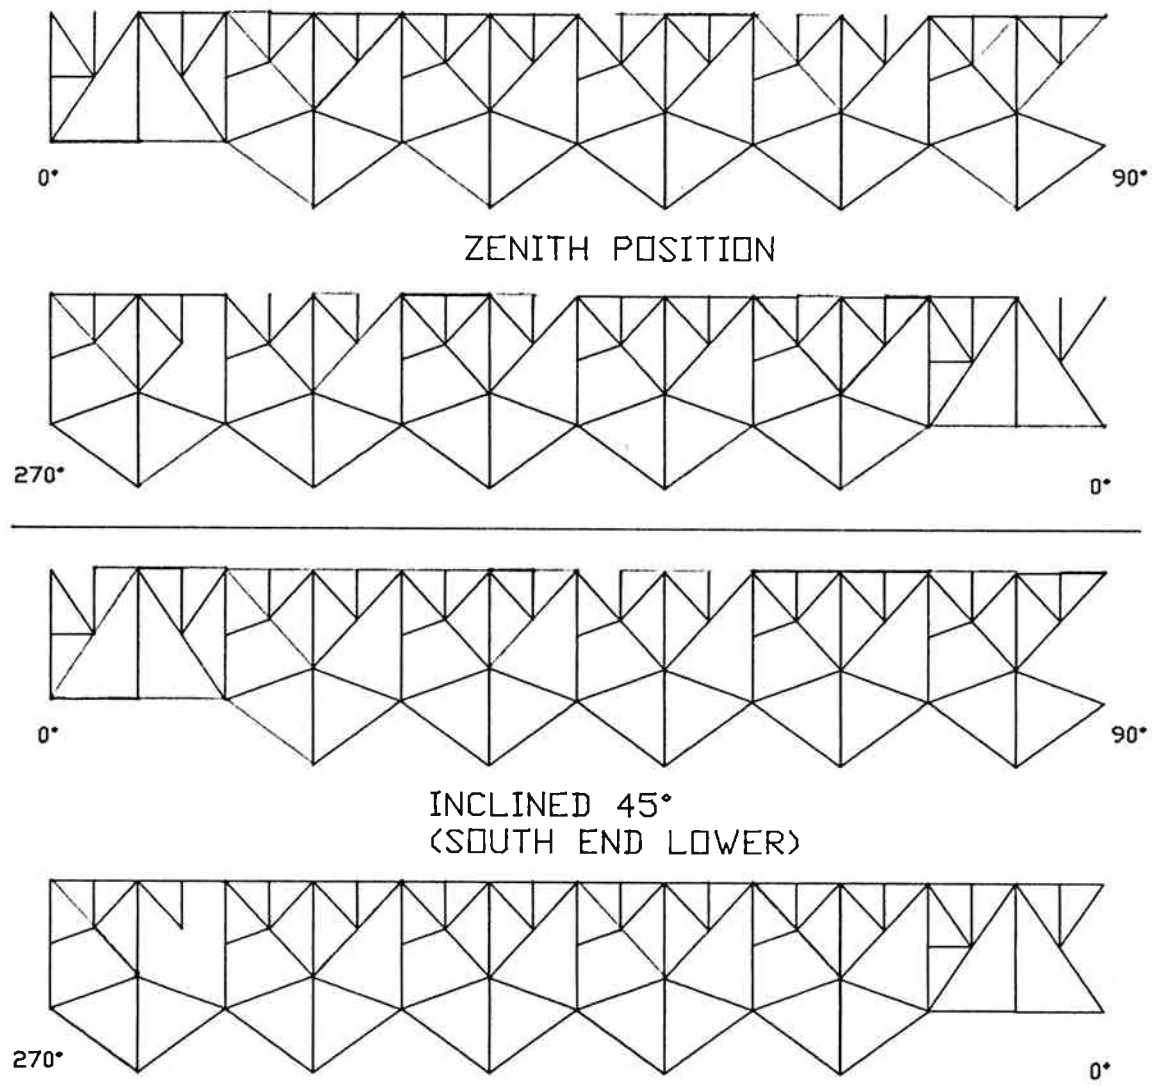
FIGURE NO. 2-27
300 FT. RADIO TELESCOPE
GREEN BANK, WV.,
CIRCUMFERENCE 7,
MEMBER OVERSTRESSES
ZENITH & 45° INCLINED
DISH POSITION

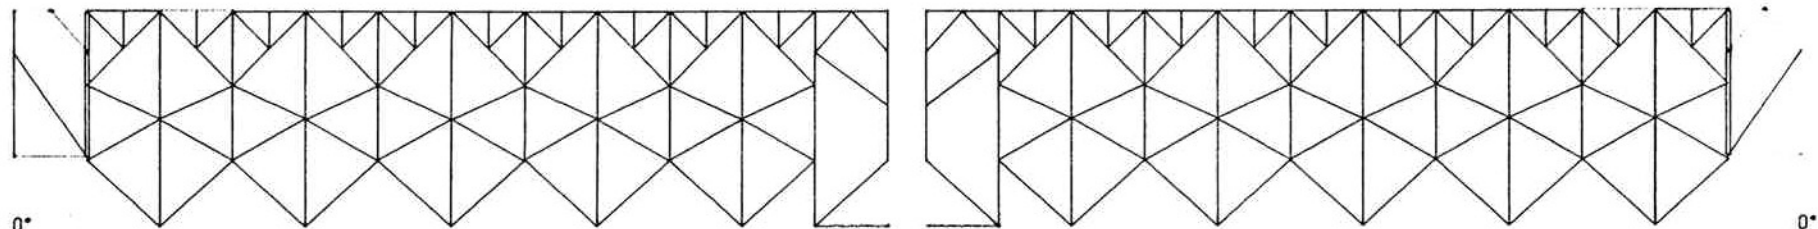
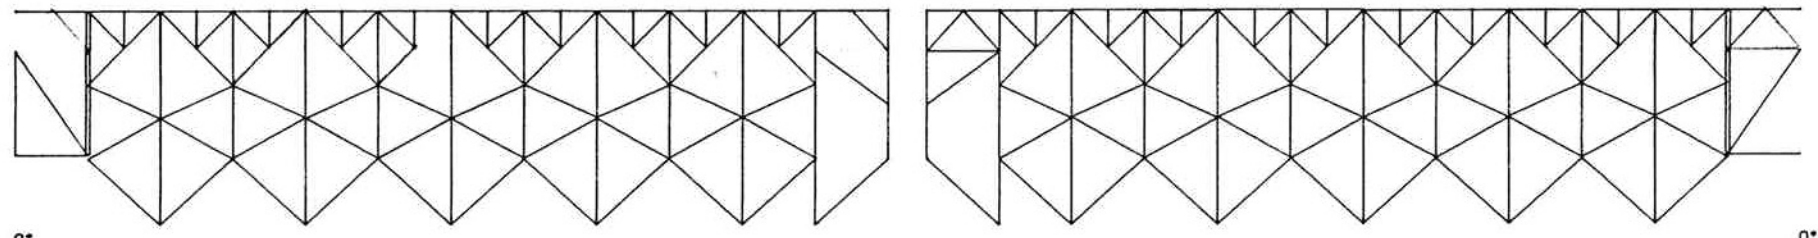
FIGURE 2-28
300 FT. RADIO TELESCOPE
GREEN BANK WV_a.
CIRCUMFERENCE 8,
MEMBER OVERSTRESSES
ZENITH & 45° INCLINED DISH POSITIONS

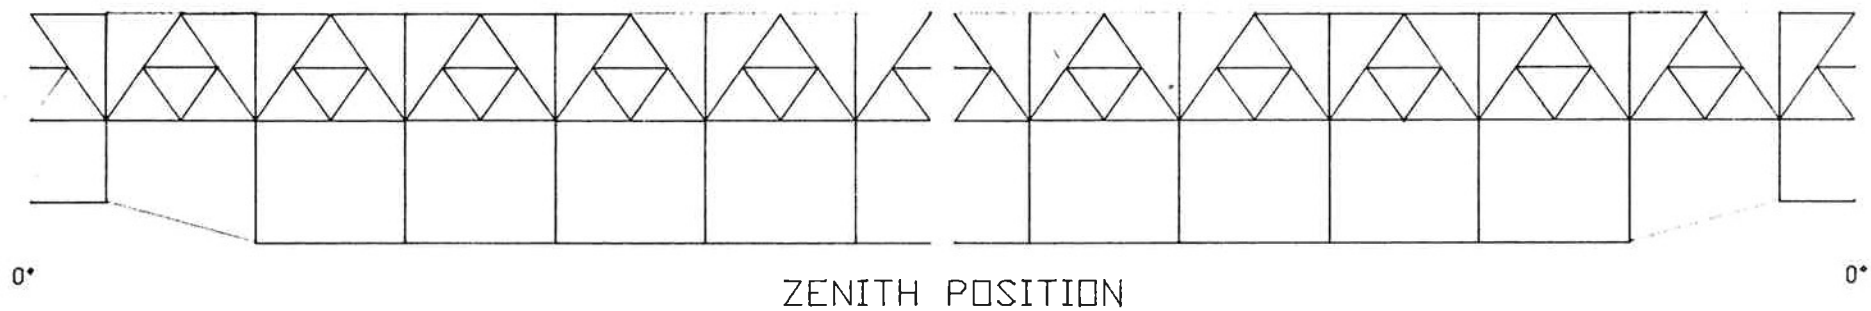
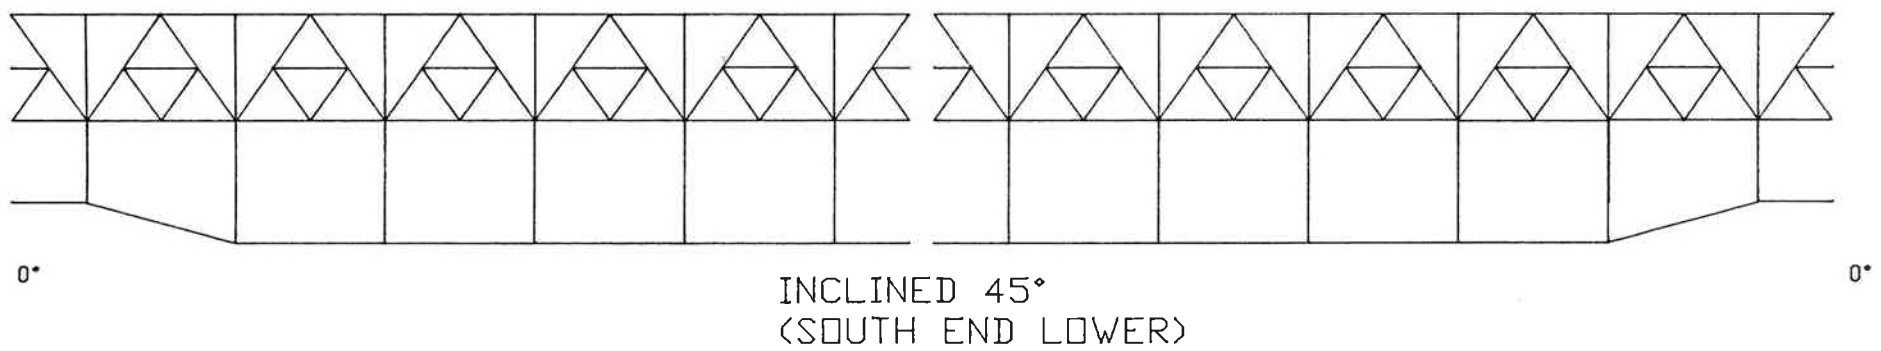
FIGURE NO. 2-29
300 FT. RADIO TELESCOPE
GREEN BANK, WV_a.
CIRCUMFERENCE 9,
MEMBER OVERSTRESSES,
ZENITH & 45° INCLINED DISH POSITIONS

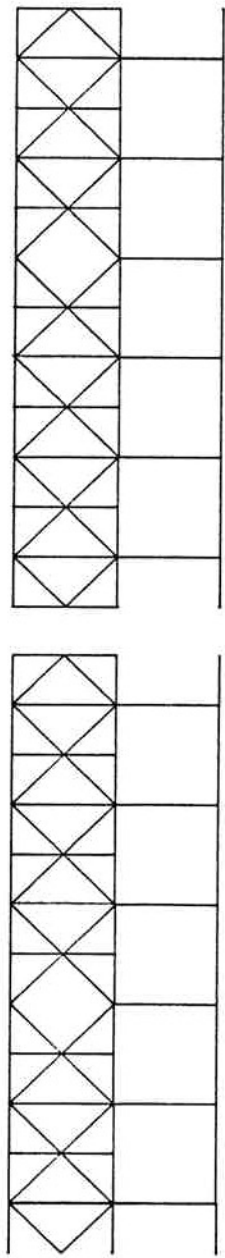
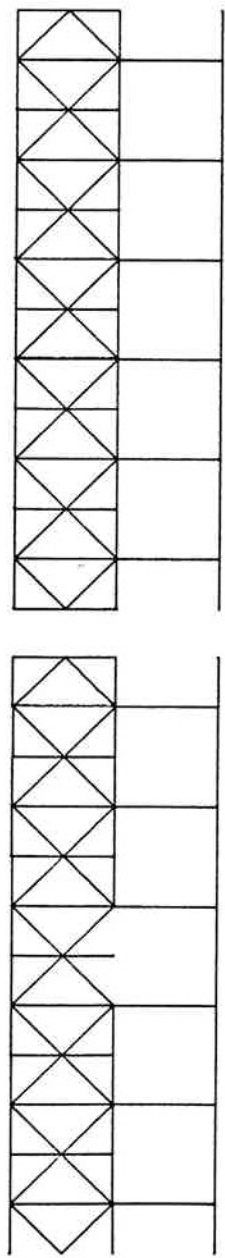
FIGURE NO. 2-30
300 FT. RADIO TELESCOPE
GREEN BANK WV^a.
CIRCUMFERENCE 10
MEMBER OVERSTRESSES,
ZENITH & 45° INCLINED

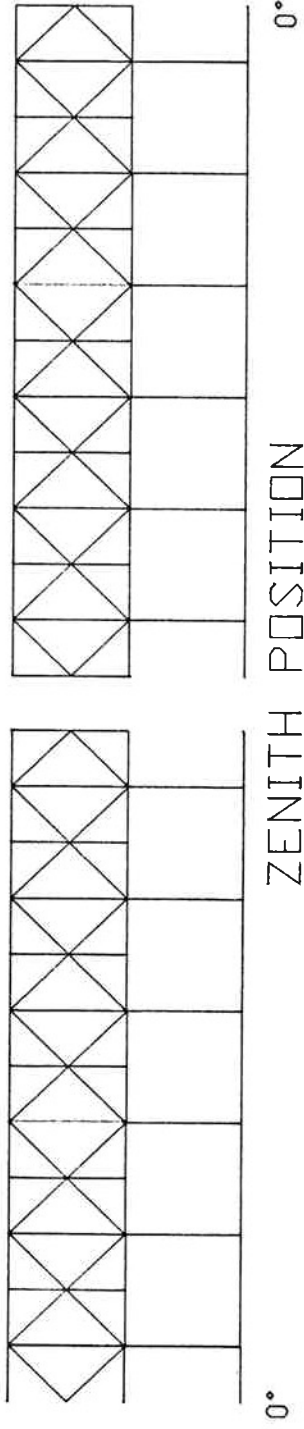
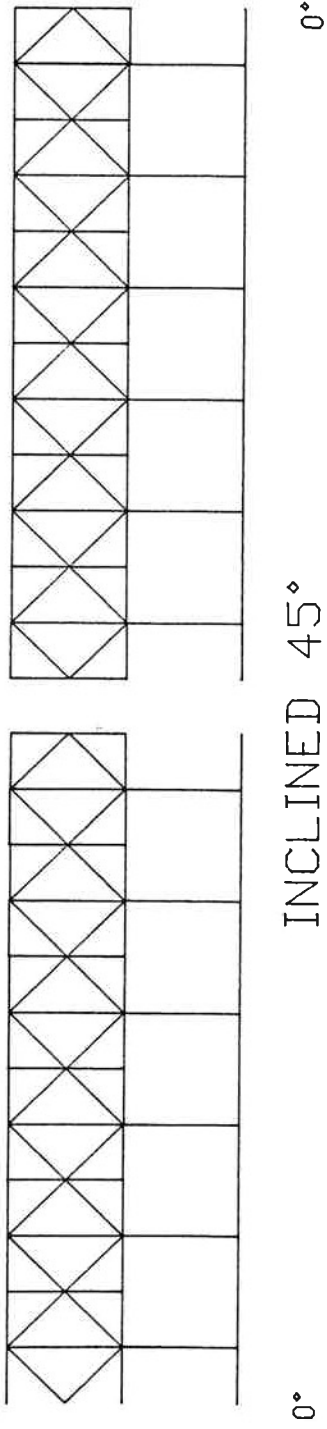
FIGURE 2-31
300 FT. RADIO TELESCOPE
GREEN BANK WV^a.
CIRCUMFERENCE 11
MEMBER OVERSTRESSES,
ZENITH & 45° INCLINED

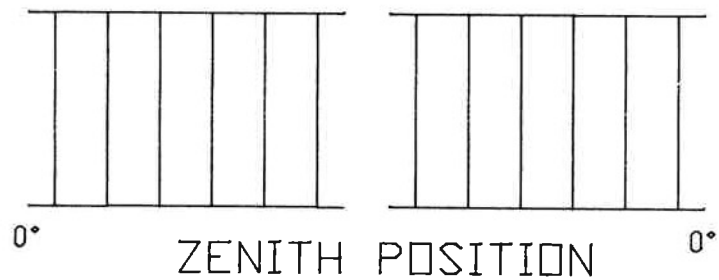
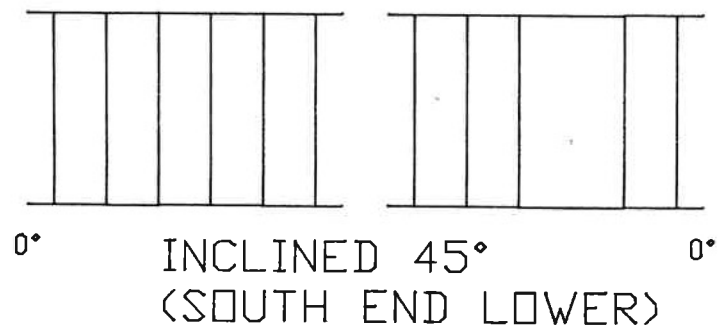
FIGURE 2-34
300 FT. RADIO TELESCOPE
GREENBANK, WV.
CIRCUMFERENCE 14,
MEMBER OVERSTRESSES
ZENITH & 45° INCLINED POSITION

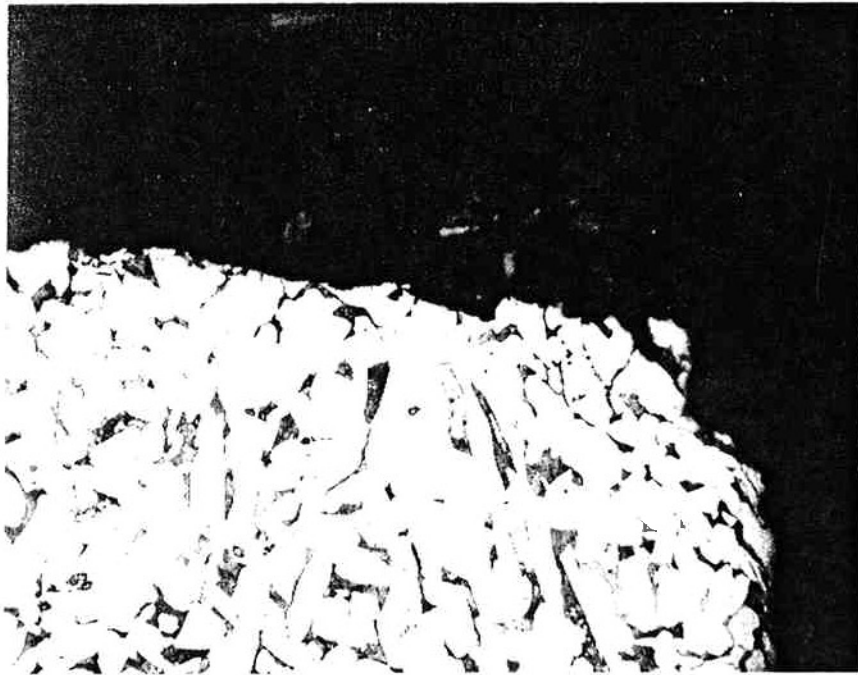
Examination of the fracture regions adjacent to the bolt holes revealed fracture profiles which were relatively flat and transgranular (propagating through the grains rather than along grain boundaries), as is typical of progressive or fatigue failure under cyclic loading. Fig. 9 is a photomicrograph showing the transgranular fracture profile adjacent to a bolt hole. Further, as shown in Fig. 10, small secondary transgranular cracks parallel to the primary fracture were also observed at the bolt hole surfaces. The presence of secondary cracks are characteristics of fatigue fracture at moderate to high cyclic stresses.

FRACTURE PROFILE AT ORIGIN

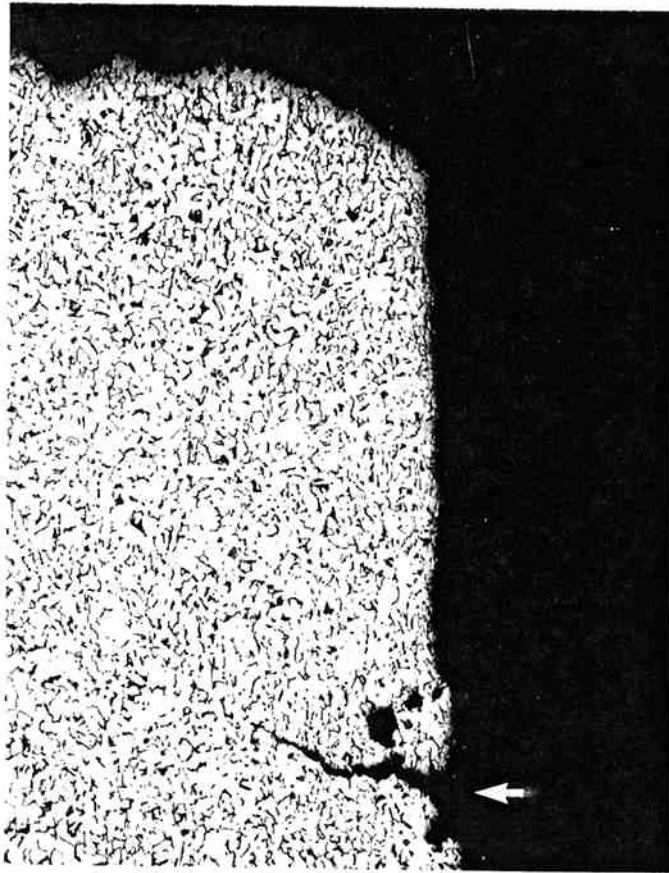
Fig. 10

Further, the results of the fractographic examination revealed secondary fatigue cracks also had originated at the bolt hole surfaces. The presence of the secondary fatigue cracks at the bolt holes indicates the presence of intermediate to high cyclic stresses.

SECONDARY FATIGUE CRACK

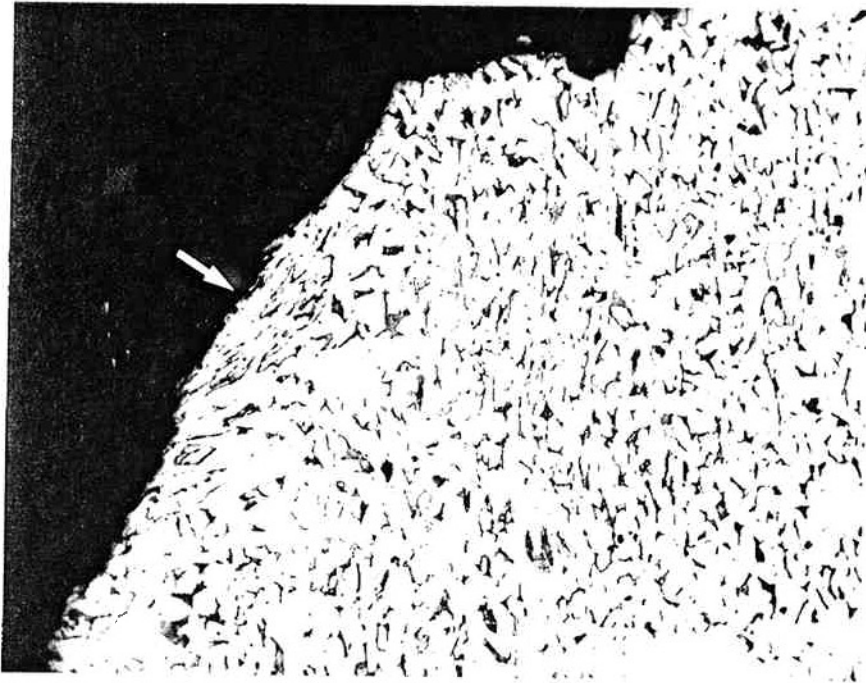
Remote from the fracture origin, the final fracture profile was slanted, transgranular and the grains adjacent to the surface were plastically deformed, as is characteristic of fast ductile fracture. Fig. 11 is a photomicrograph showing fracture profile through the final fracture region.

FRACTURE PROFILE REMOTE
FROM BOLT HOLE ORIGIN

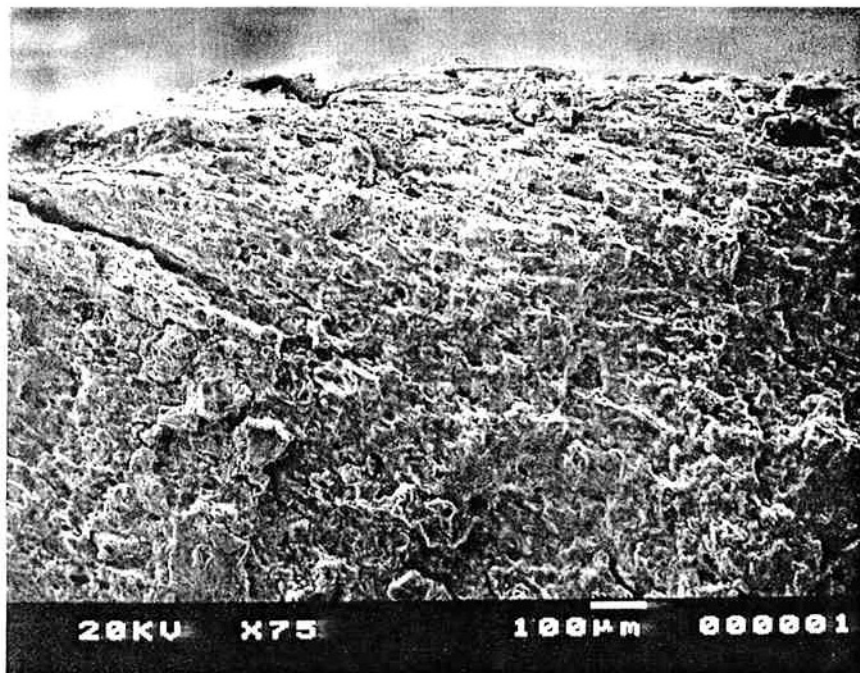
Fig. 12

As shown in Fig. 12, the fracture surface was covered with an oxide scale and no significant fractographic information was obtained.

FRACTURE ORIGIN AT ORIGIN
