II. EVENT RECONSTRUCTION

A. LCU Failure 2009-08-02 T22:43:00Z

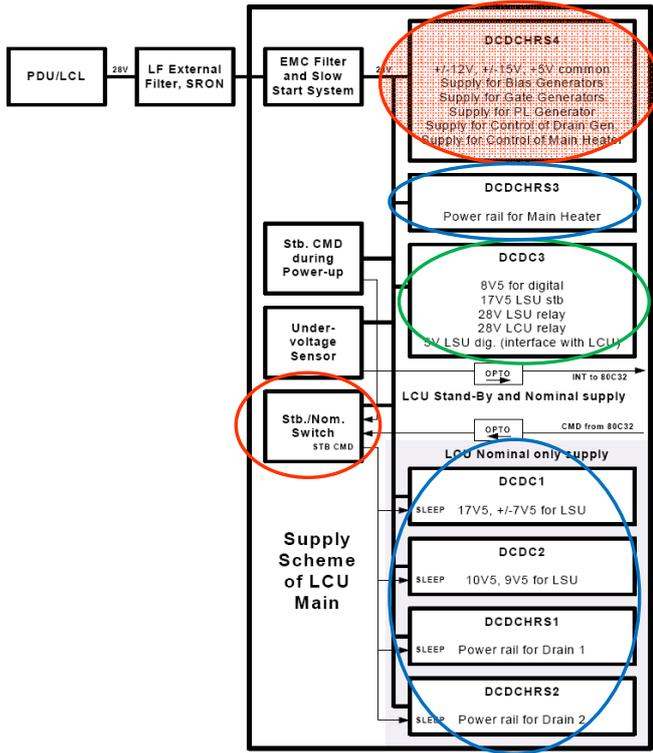
Fig. 2 Electrical block diagram of the Local oscillator Control Unit (LCU) showing the groups of DC/DC convertors.

Using the refurbished QM model of the LCU (IMD-3) an initial evaluation of the power consumption of the electronic modules was made in order to explain the low primary power consumption of the LCU (0.36A in Fig. 4). The main conclusion was that only a failure in DC-DC convertor HRS-4 in combination with a switched standby relay as shown in Fig. 2 would explain such low power consumption. All other combinations of single failures in DC-DC convertors would lead to higher power consumption than observed. Simulating
